DATE: January 6, 2021

FROM: Morgan Holen, Consulting Arborist

RE: Schultz Farm – Reassessment of Trees 70504, 70522 and 70523

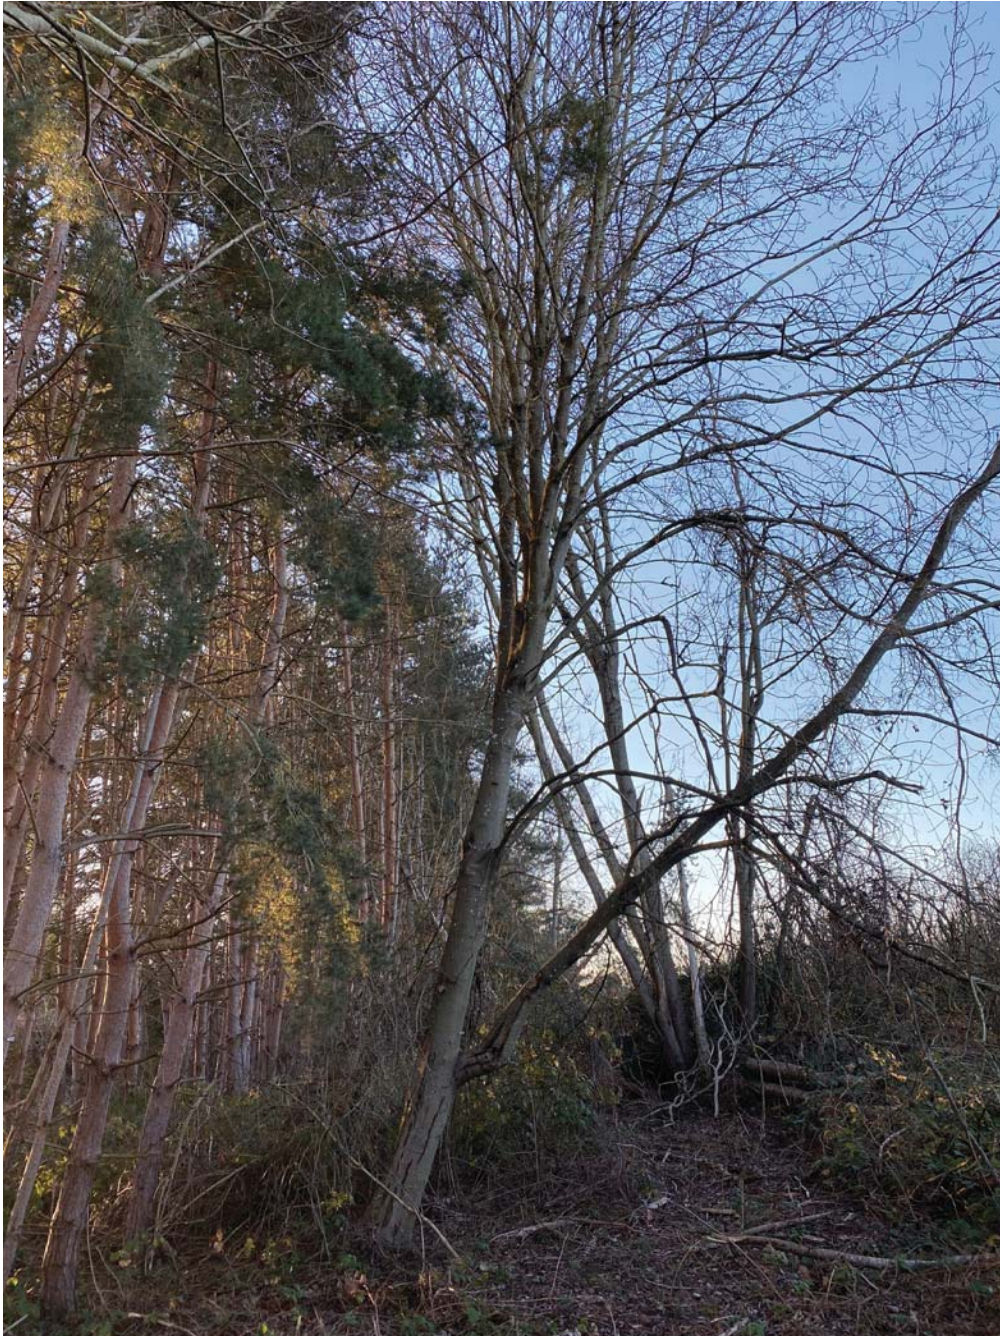
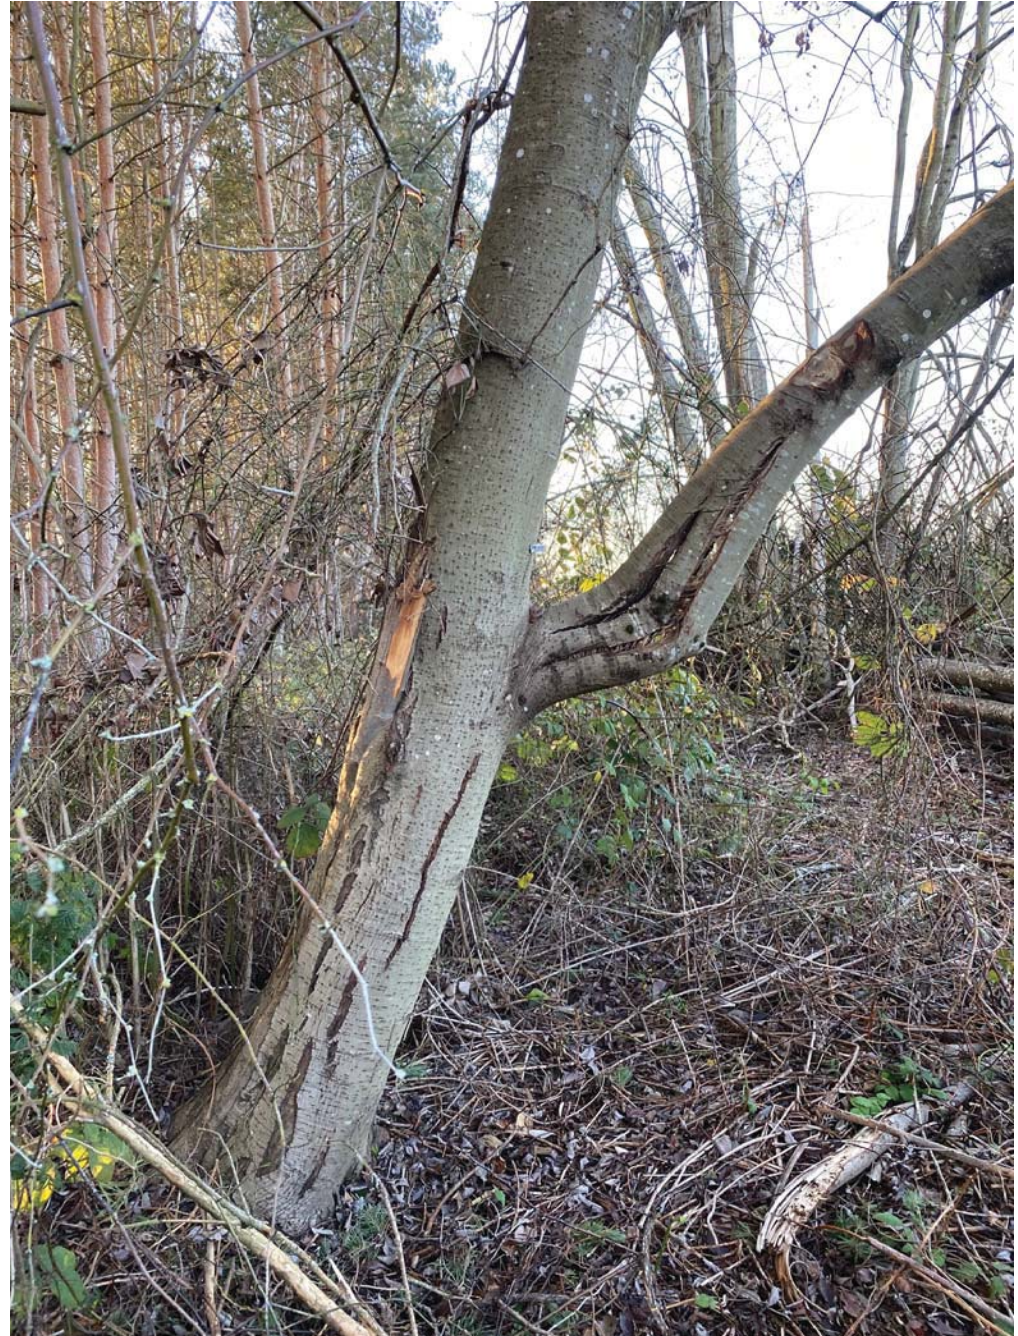
Tree 70504 is a 16-inch diameter Scouler's willow (*Salix scouleriana*) in poor condition and with poor structure including lean, multiple leaders with included bark, a history of branch failure, a low-lying scaffold branch with a sheer plane crack and a suspicious sunken area on the south side of the lower trunk face where decay or included bark is suspected.

In general, Scouler's willow is a fast-growing and short-lived species with brittle wood and is vulnerable to trunk decay with maturity. Tree 70504 is the same species and size as nearby tree 70499, which appears to have had similar structure to tree 70504 before it failed; tree 70499 split in two with codominant stems failing in opposing directions. Considering its species, size and structural defects, the likelihood of failure of tree 70504 is high, which is why it was proposed for removal in the October 27, 2020 arborist report. However, if this tree were to fail, the target potential is low. The closest rear lot line proposed to the north is just over 120-feet away and there are no paths proposed to the north. In other directions, the tree could strike other nearby trees but is not within striking distance of proposed trails to the south and west. The only potential targets are people who may occasionally wander off the paths in the open space tract.

Photos 1 and 2. Tree 70504 - A 16" diameter Scouler's willow in poor condition located on the north edge of the scots pine stand with poor structure including lean, multiple leaders with included bark, and a scaffold branch with a sheer plane crack.

Although tree 70504 is not considered high risk due to low target potential, the tree is expected to fail and is not a long-term amenity to the open space. Its habitat value could be replaced by more diverse new plantings. Therefore, I continue to recommend removal of this willow tree.

Based on this reassessment, I continue to recommend removal of tree 70504, leaving large woody debris from the tree on-site in direct contact with the ground and replanting the general vicinity of the tree with a more diverse mix of long-lived trees, and creating snags out of trees 70522 and 70523 by reducing their heights to a maximum of 15-feet and girdling the trunks.

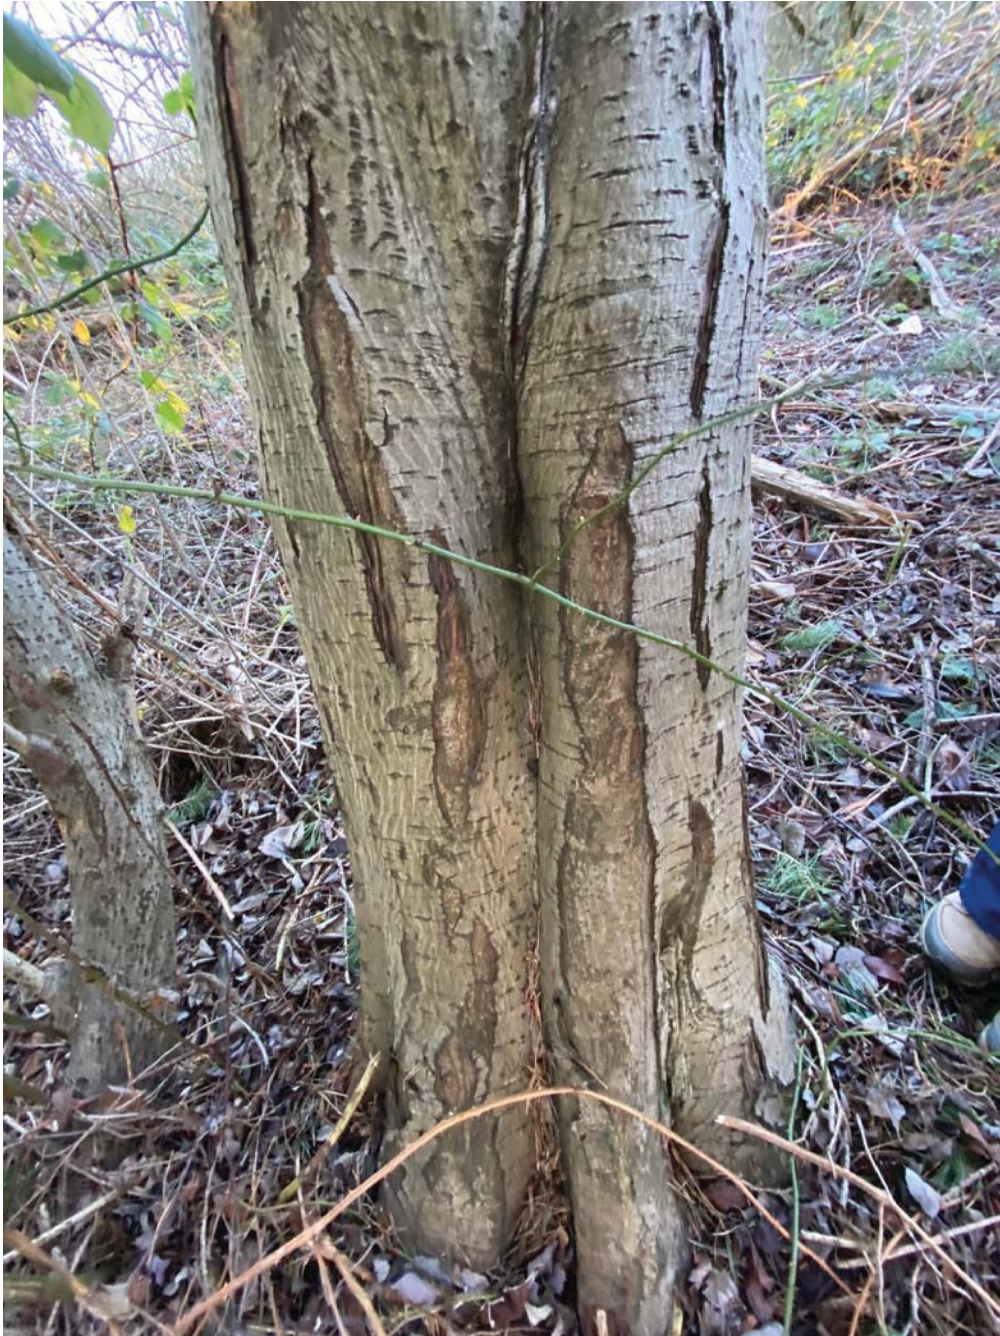
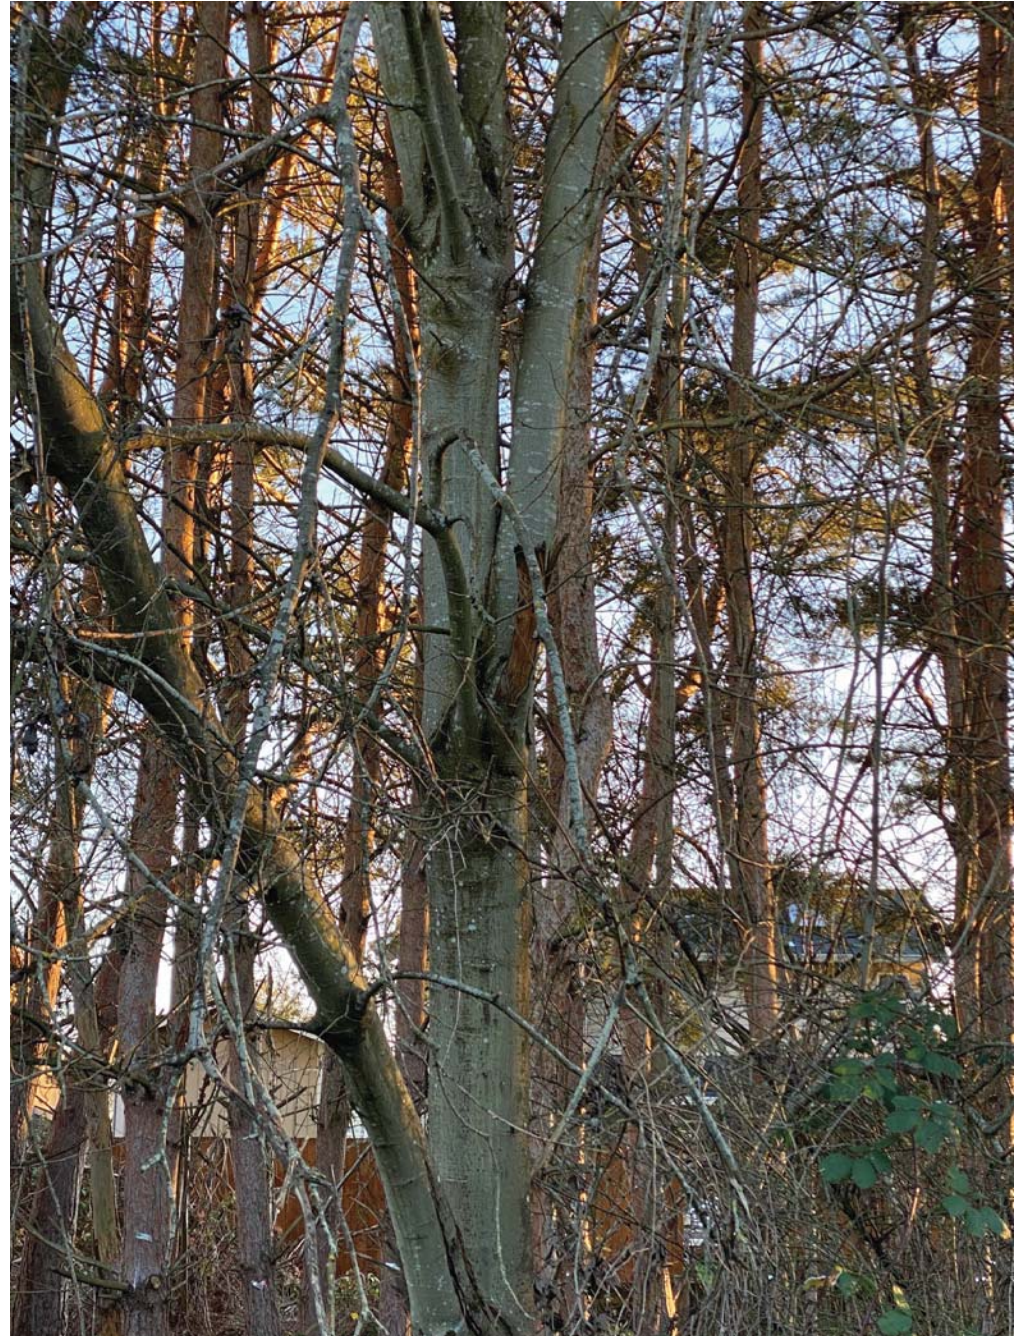
Photos 3 and 4. Tree 70504 - A closer look at the 16" diameter Scouler's willow showing the south side of the lower trunk with a suspicious sunken area where decay or included bark is suspected (left) and multiple leaders with included bark and a history of branch failure (right).

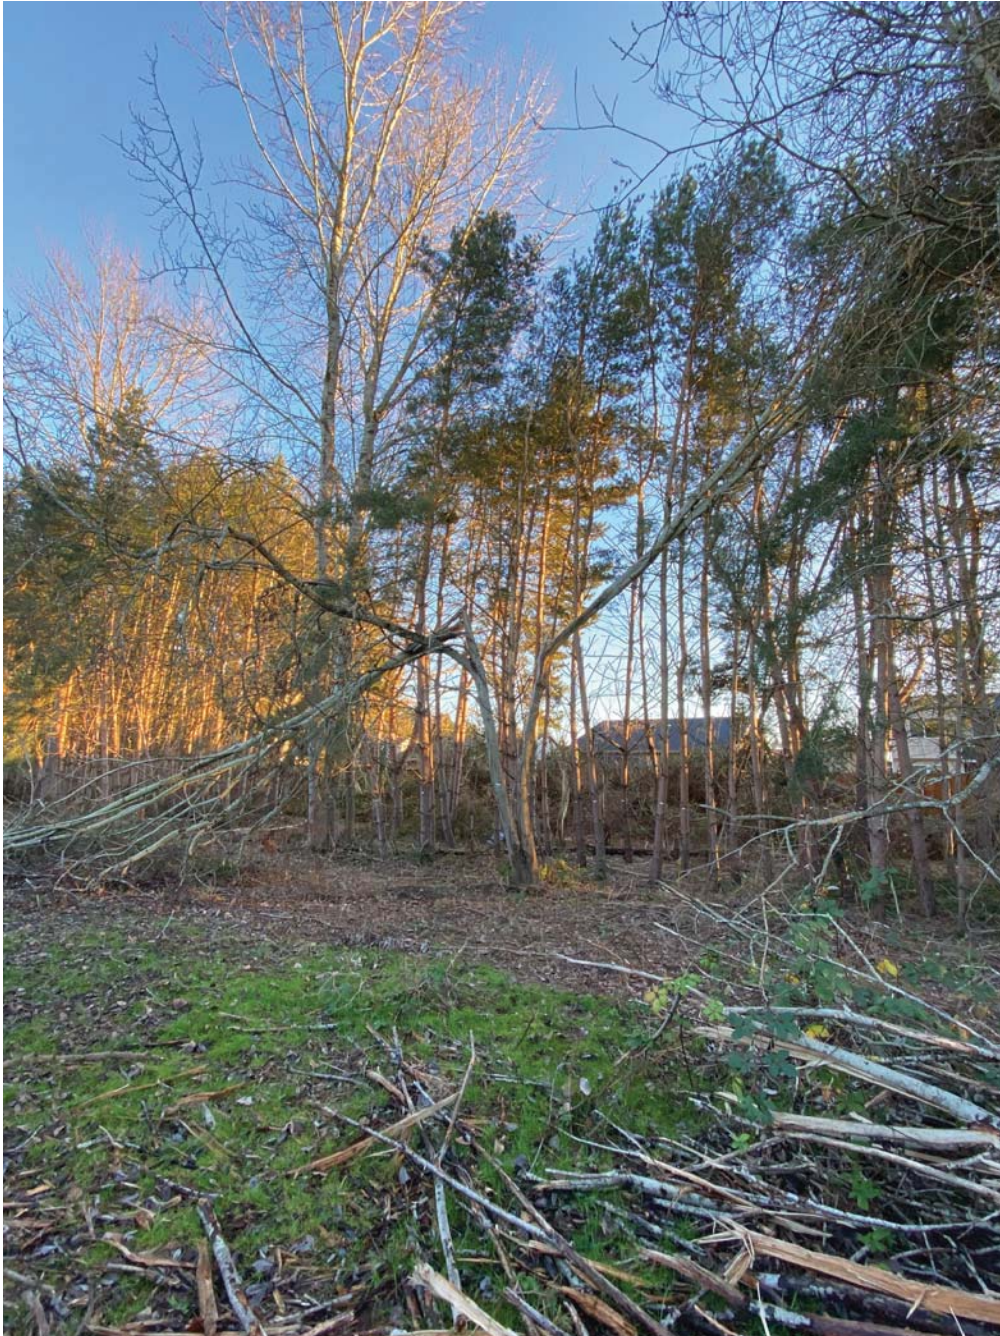
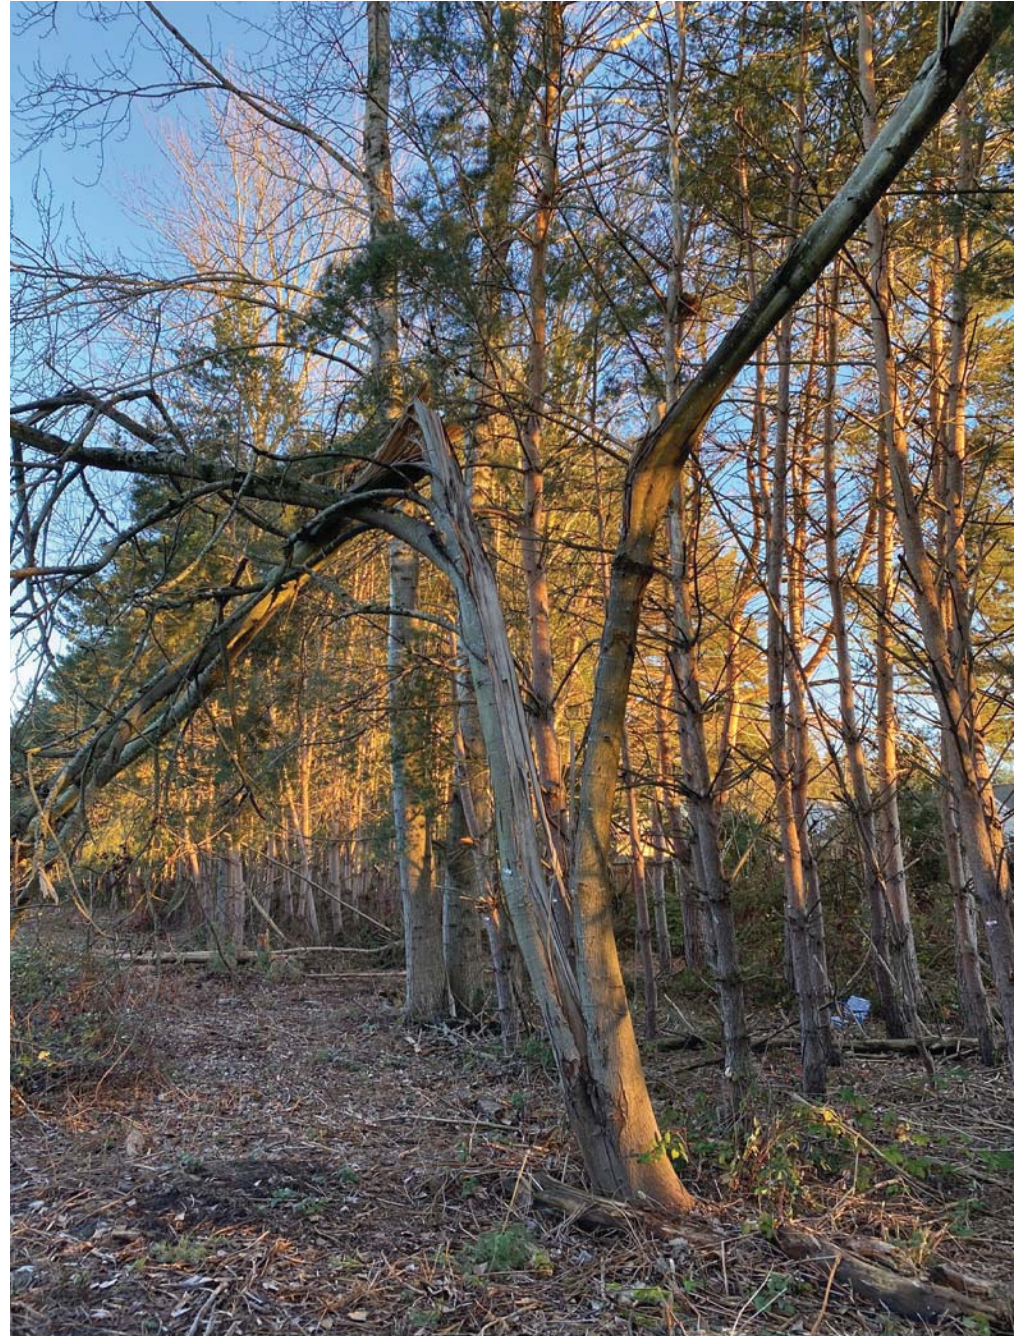
Photos 5 and 6. Tree 70499 - A dead 16" diameter Scouler's willow located east of tree 70504 shown as an example of what is expected to happen to tree 70504. Both trees are the same species and size and with similar structure. Tree 70499 has already failed by splitting in two. The likelihood of failure in tree 70504 is high.

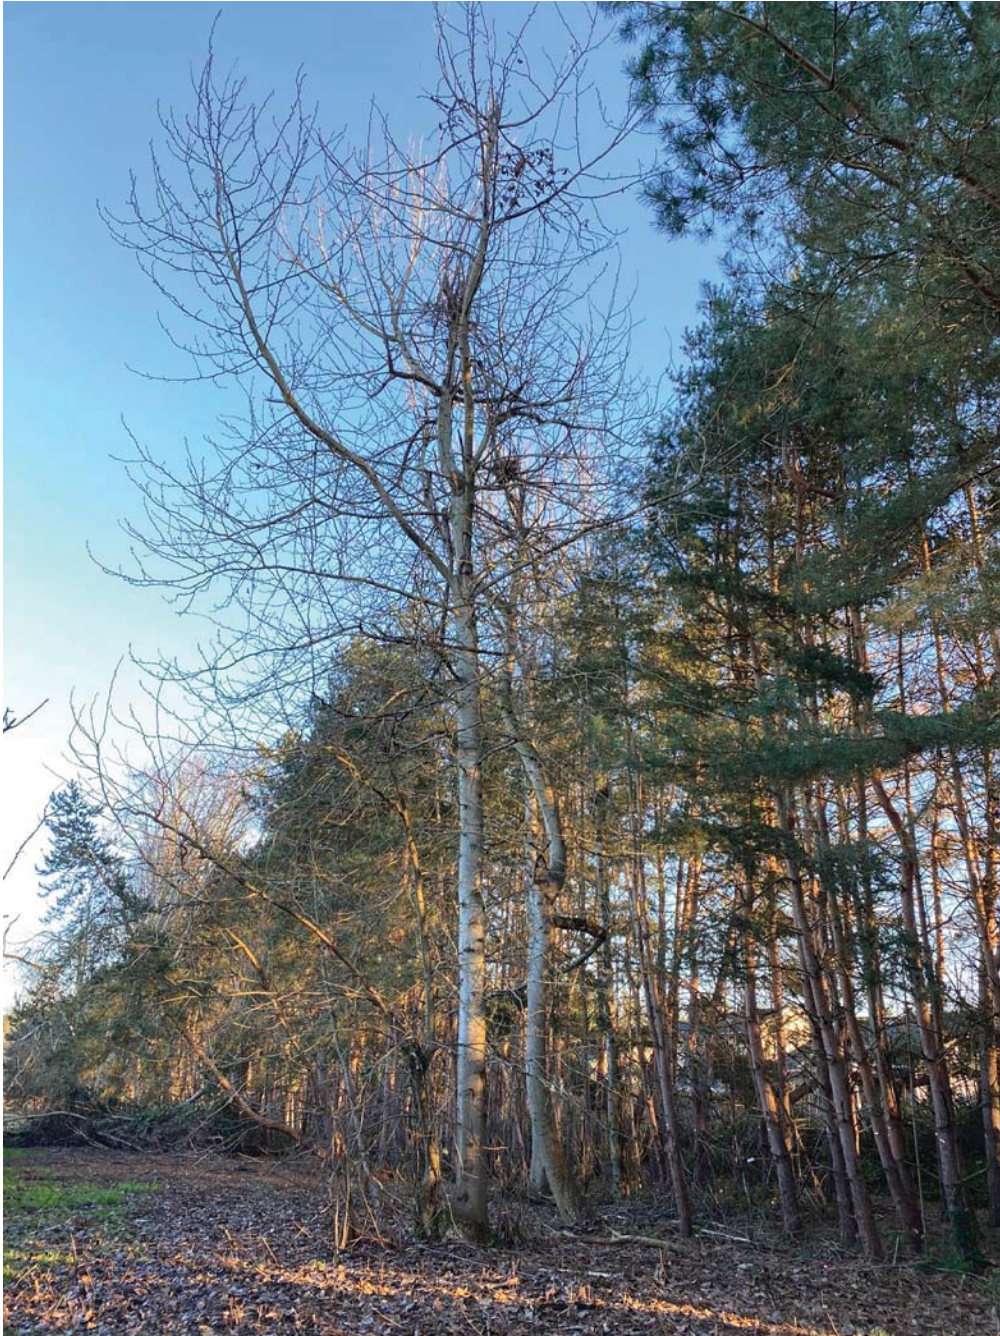
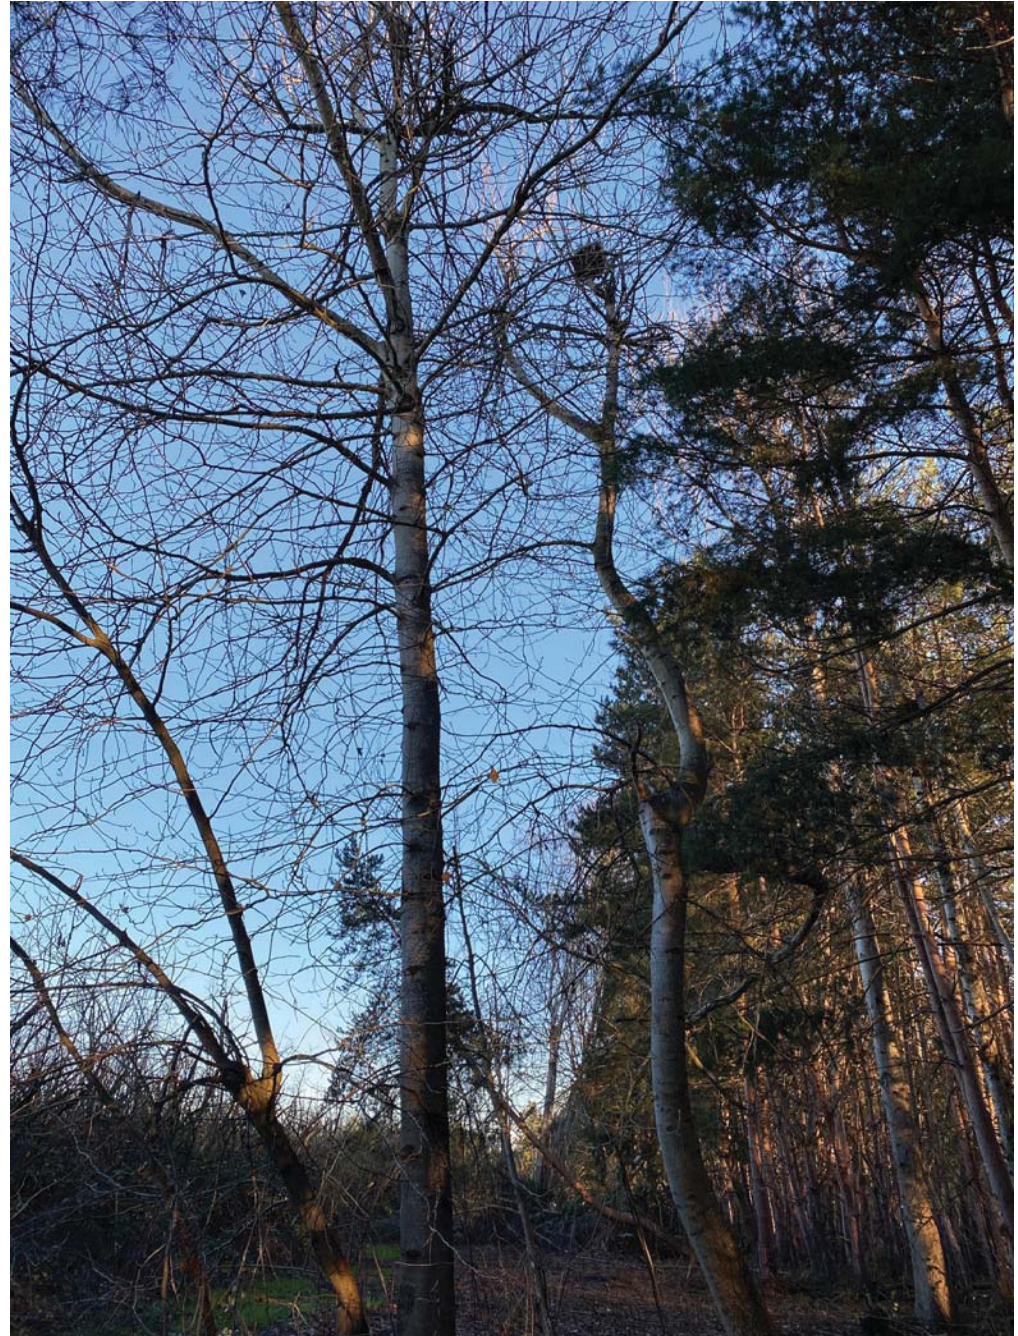
Trees 70522 and 70523 are black cottonwoods (*Populus trichocarpa*) located adjacent to one another. Tree 70522 is 14-inches in diameter and in poor condition with very poor structure including a crooked trunk, history of large branch failure, and an old broken top with a new off-center leader. Tree 70523 is 15-inches in diameter and has a 6-inch diameter spur leader with excessive lean to the north. This tree is in fair condition but with poor structure including a history of large branch failure and crown decay.

In general, black cottonwoods are very fast growing and relatively short-lived trees that have inherent limitations because they are notoriously weak-wooded and tend to break apart with maturity. Where black cottonwoods are growing within striking distance of potential targets, including people and property, they generally become hazardous over time since the probability for failure increases with maturity. The shallow root system of black cottonwoods also makes these trees relatively more susceptible to failure at any age during wind events, ice storms, and snow. Eight other black cottonwoods in fair to good condition are planned for retention in the open space tract. However, these two trees have more notable and severe structural defects and are exposed along the edge of the stand. These trees were proposed for removal in the October 27, 2020 arborist report because of hazard risk potential.

Trees 70522 and 70523 are approximately 60-feet in height. If either tree were to fail, the striking distance could be 1.5 times the height of the tree, or 90-feet. While the closest lot lines proposed to the north are 112-feet away, a path is proposed within 29-feet of the trees. The path could be adjusted to the north to stay 90-feet away, however the trees are only semi-mature and could continue to grow taller and more susceptible to failure. Mature black cottonwoods are commonly 125- to 150-feet in height. Even at 100-feet in height, the trees would be well within striking distance of the proposed development including buildings and people. Due to hazard risk potential, I continue to recommend removal of trees 70522 and 70523.

Photos 7 and 8. Trees 70522 and 70523 - In both photos, tree 70522 is right of tree 70523, looking east. Both trees are black cottonwoods located on the north edge of the scots pine stand. Tree 70522 is 14" diameter and in poor condition with very poor structure including a crooked trunk, history of large branch failure, and an old broken top with a new off-center leader. Tree 70523 has codominant stems 6" and 15" diameter each in fair condition but with poor structure including a history of large branch failure and crown decay.

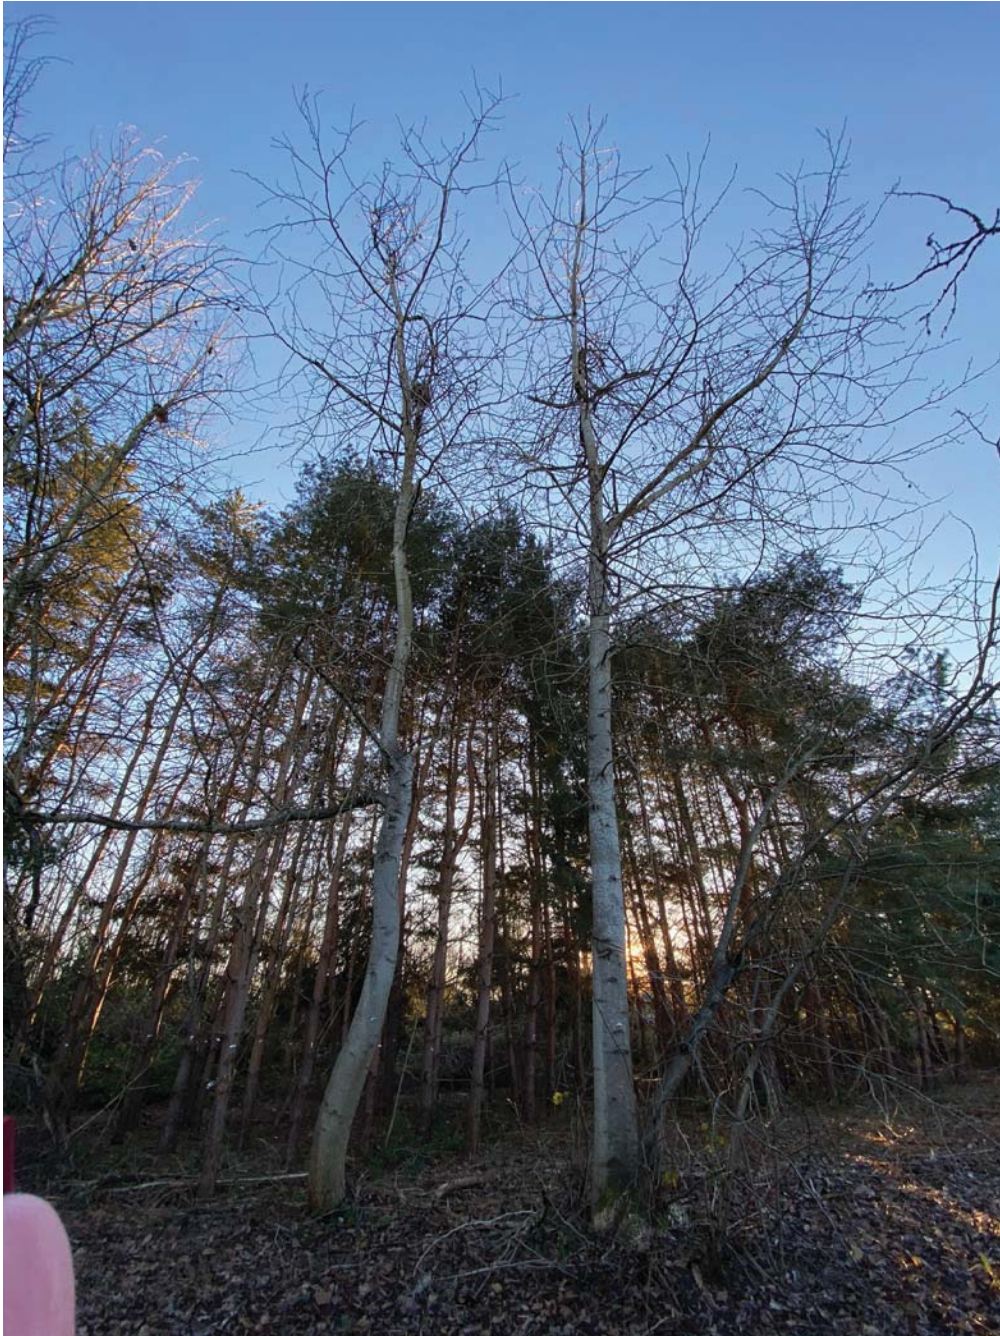
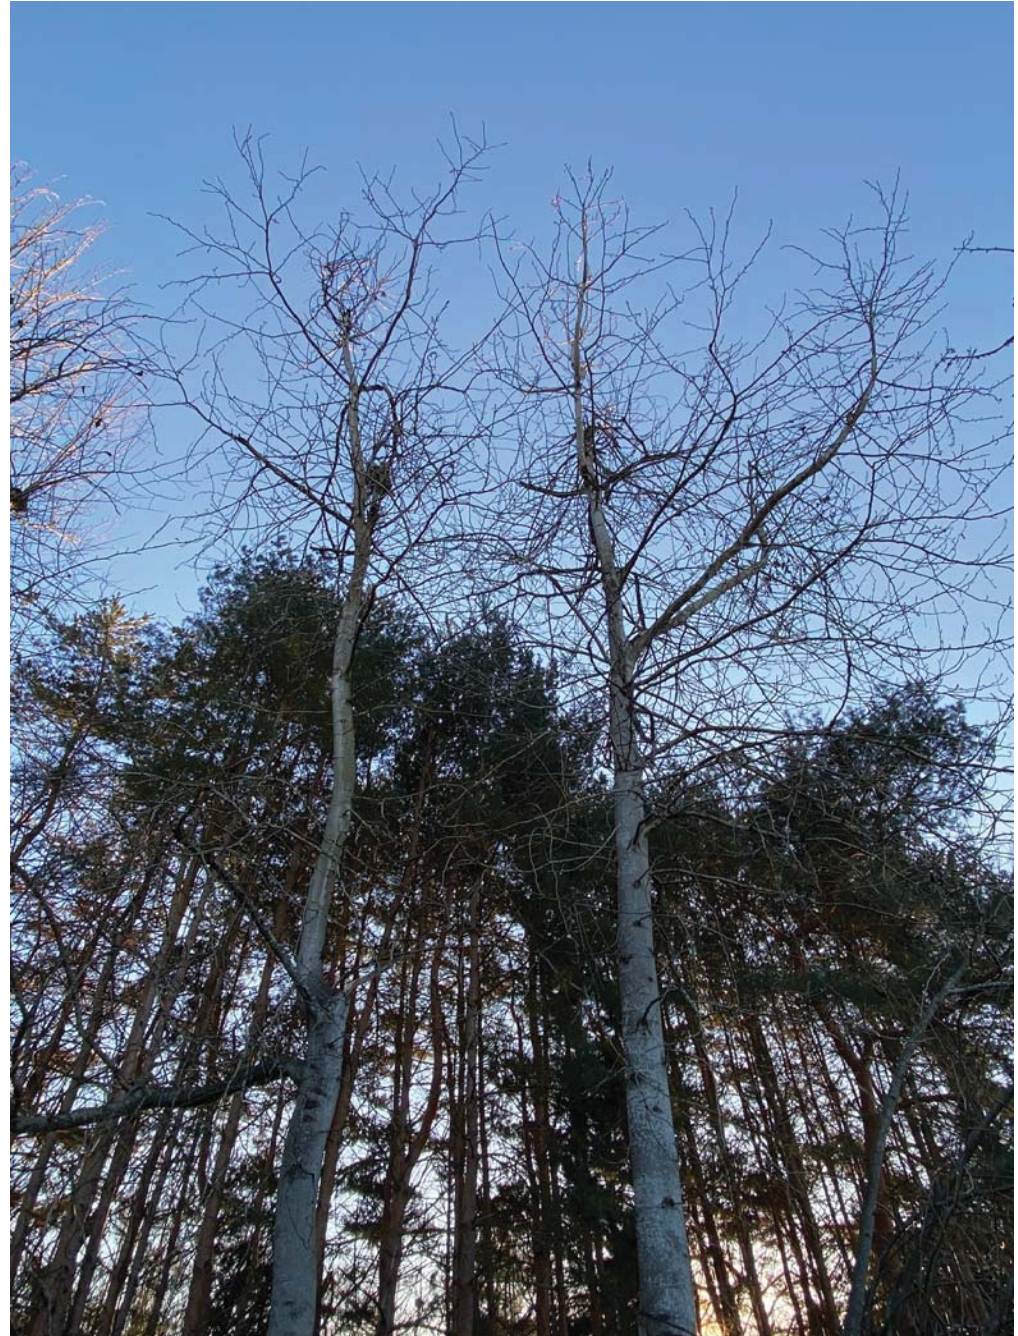
Photos 9 and 10. Trees 70522 and 70523 - In both photos, tree 70522 is left of tree 70523, looking southwest. These photos provide a closer look at off-center leader originating from an old broken top at tree 70522, which also has poor lateral branch distribution due to a history of branch failure. Photo 9 (left) shows the 6" diameter leader with excessive lean near the base of the main stem. Photo 10 (right) shows the upper crown of the 15" diameter main stem of tree 70523 with poor lateral branch distribution due to a history of branch failure.

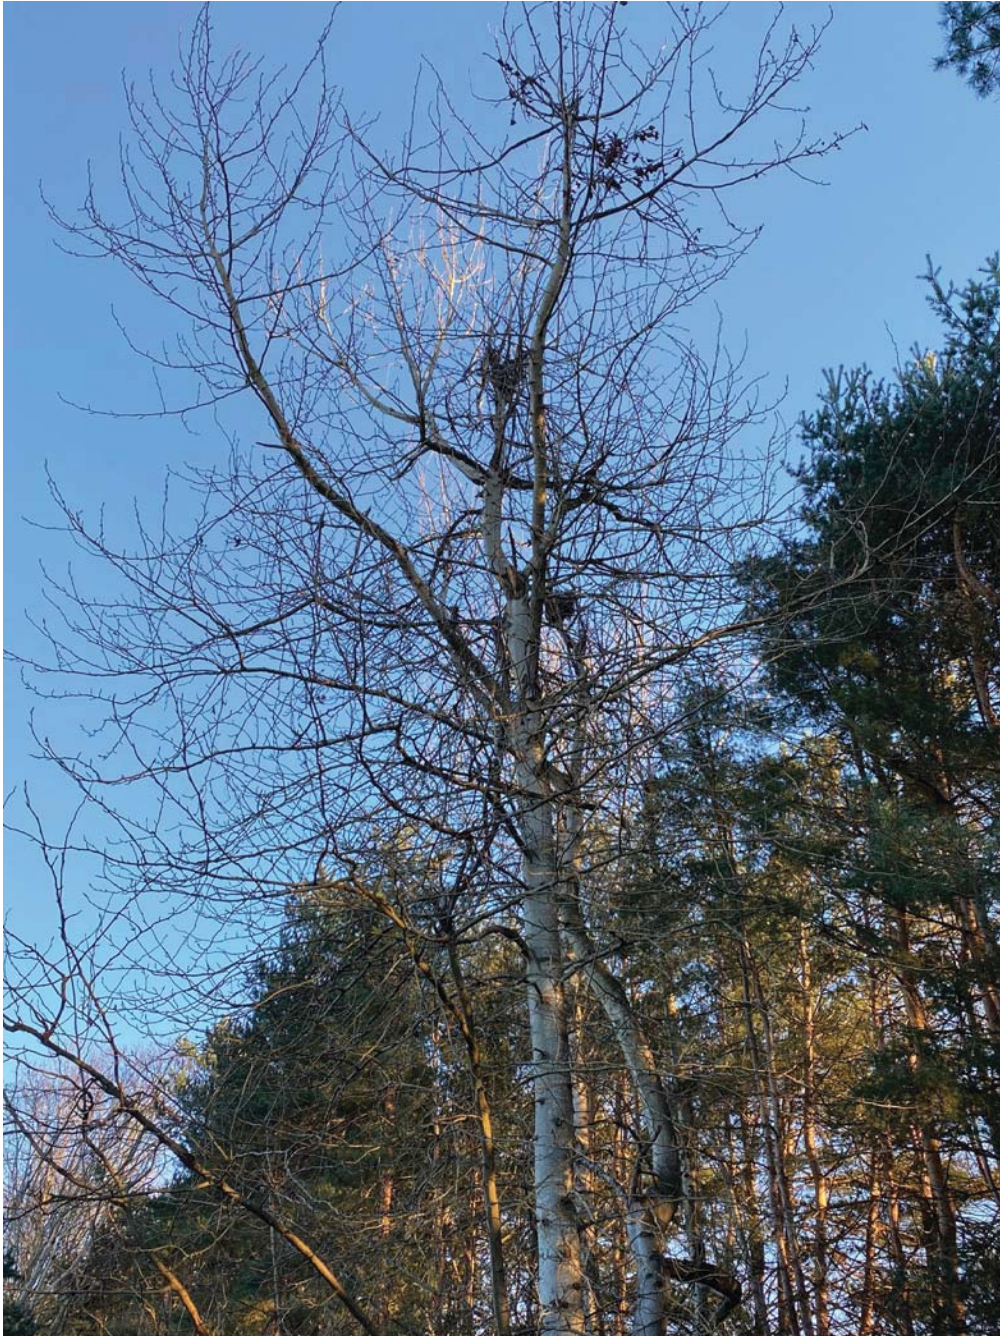
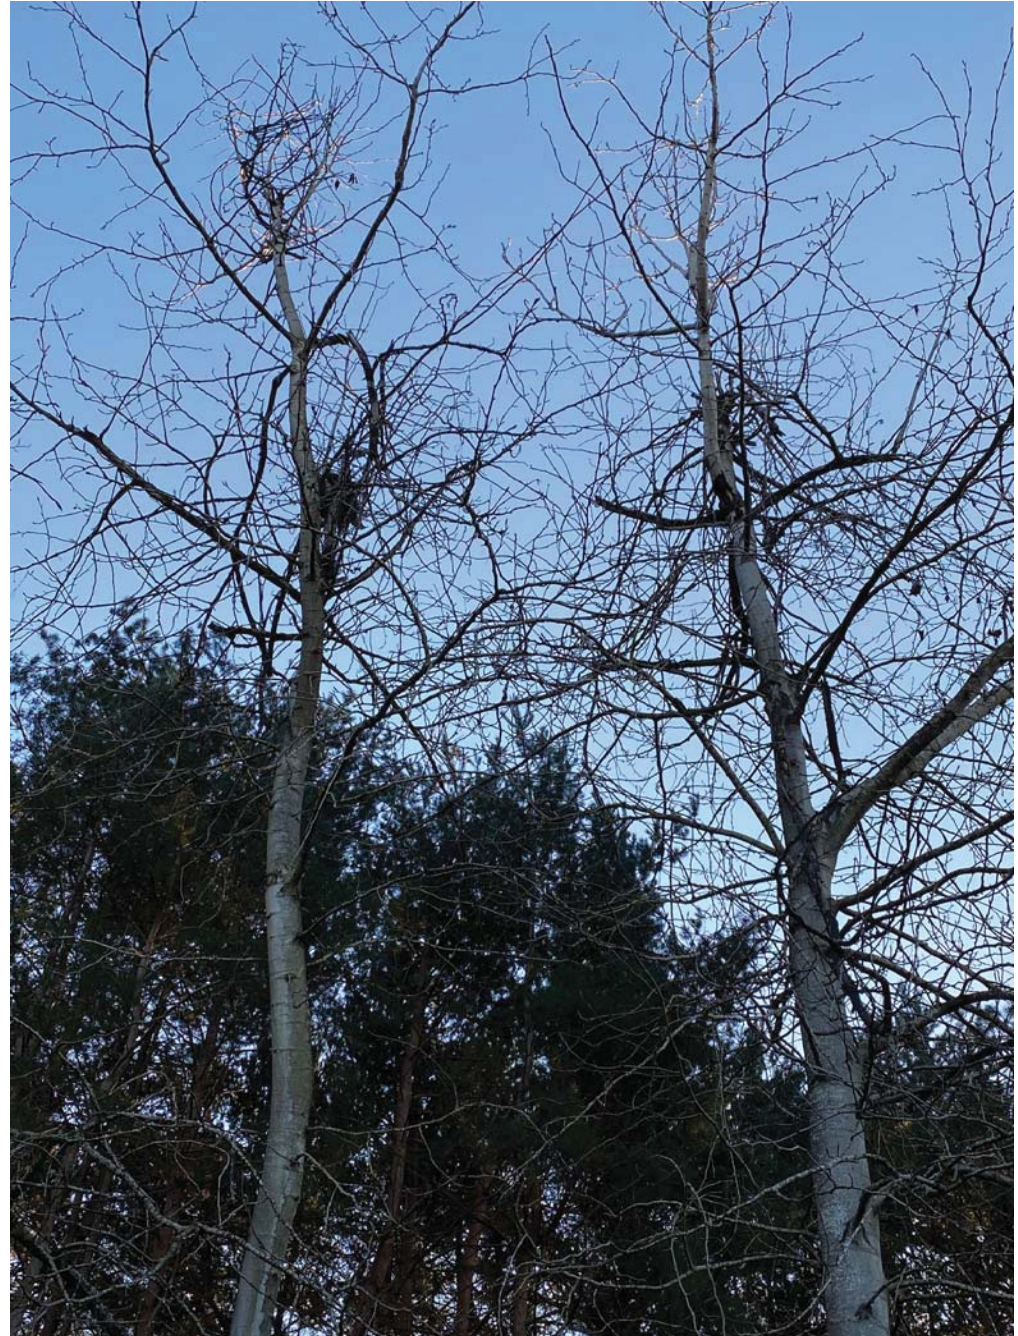
Photos 11 and 12. Trees 70522 and 70523 - Another view of the crowns of both trees showing poor structure and a history of branch and leader failure.
