# Memo

**Re:** Dove Landing Playground Safety Audit and Park Amenity Walk

City of Woodburn Certified Playground Safety Inspector (CPSI) Jeff Crabtree conducted the playground safety audit of the play structures and surfacing at Dove Landing on **1/11/24**.

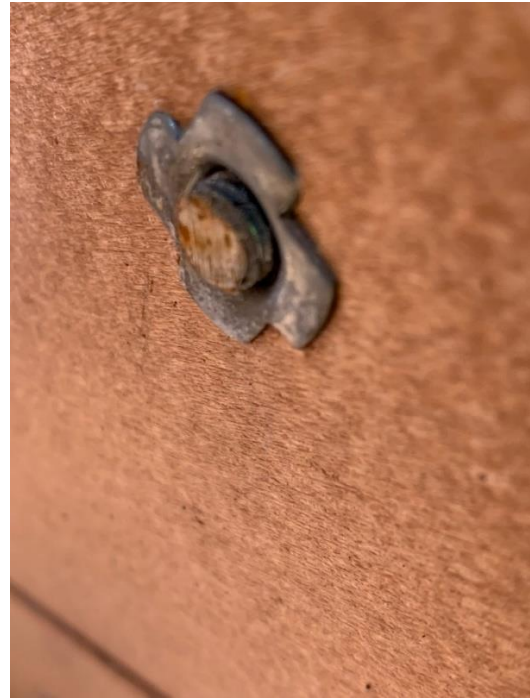
- **The rock-climbing wall is attached to the composite play structure. (photos below)**
  - o Mismatched bolts that have all been cut shorter with a cut off wheel. These cuts were left with sharp edges or burrs. These bolts are also already rusting. The fact that they are mismatched and had to be cut shorter indicates that the bolts that came with the structure may not have been used.

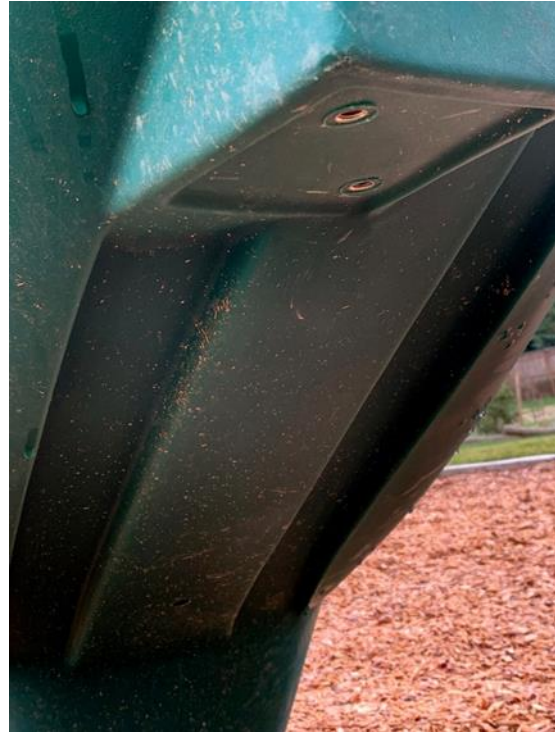
- **The slide oriented from West to East has a slight wobble, even before it has been played on. (see photos below)**
  - o The slide appears to have been designed to have a second support leg. I assume that is because the slide has a slight curve, and that second leg would be underneath the slide where it curves slightly.
