Transmittal Form: Plat Paper Check

From: Colin Cortes, AICP, CNU-A, Senior Planner Date: January 17, 2024
Cc: Chris Kerr, Community Development Director; Curtis Stultz, Public Works Director; Dago Garcia, P.E., City Engineer; Roy Reyes, Project Engineer; [Peyton James](#), Assistant Planner, Pacific Community Design (PCD); [Noah Anderson](#), Land Acquisitions Analyst, LGI Homes; [Alex Bertorelli](#), Land Development Manager, LGI Homes; Vanessa Lewis, Land Development Manager, LGI Homes; [Craig Larson](#), Project Engineer, PCD; [Travis C. Jansen](#), PE, PLS, Survey Manager, PCD ("Paper check" no. 3)
Re: Woodburn Subdivision Final Plat App FSUB 23-02 (County SP23-007) Dove Landing PUD / (County "Dove Landing"; related to City master/parent land use case file no. ANX 2020-03

Re: Dove Landing Playground Safety Audit and Park Amenity Walk

City of Woodburn Certified Playground Safety Inspector (CPSI) Jeff Crabtree conducted the playground safety audit of the play structures and surfacing at Dove Landing on **1/11/24**.

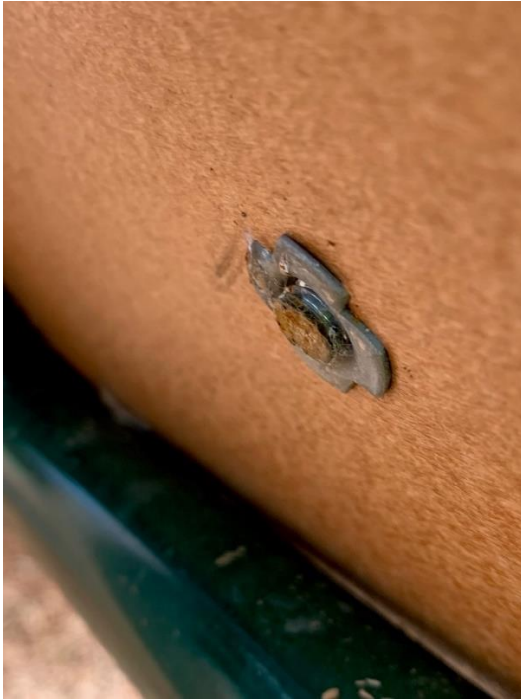
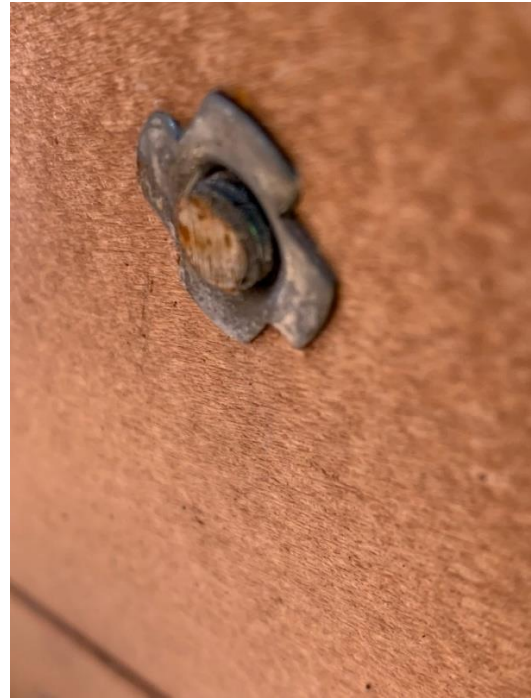
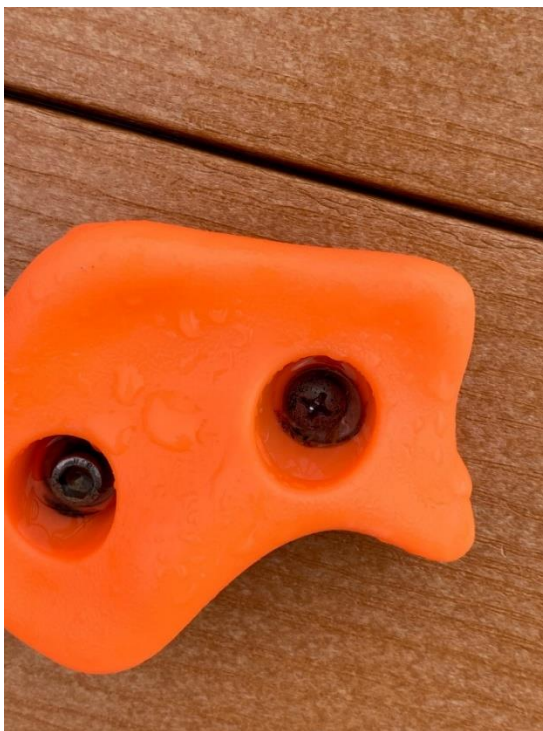
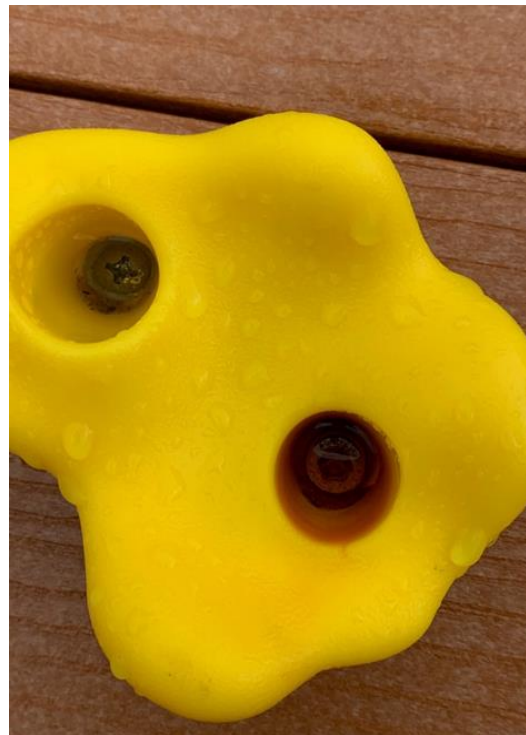
- **The rock-climbing wall is attached to the composite play structure. (photos below)**
 - o Mismatched bolts that have all been cut shorter with a cut off wheel. These cuts were left with sharp edges or burrs. These bolts are also already rusting. The fact that they are mismatched and had to be cut shorter indicates that the bolts that came with the structure may not have been used.

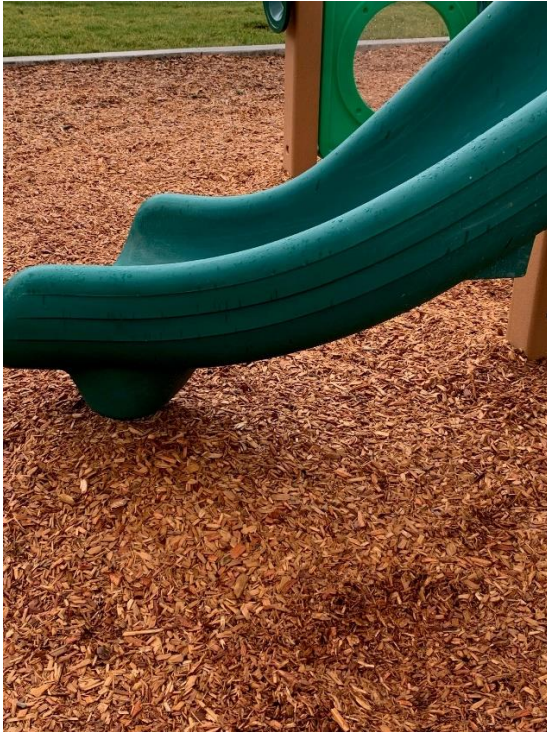
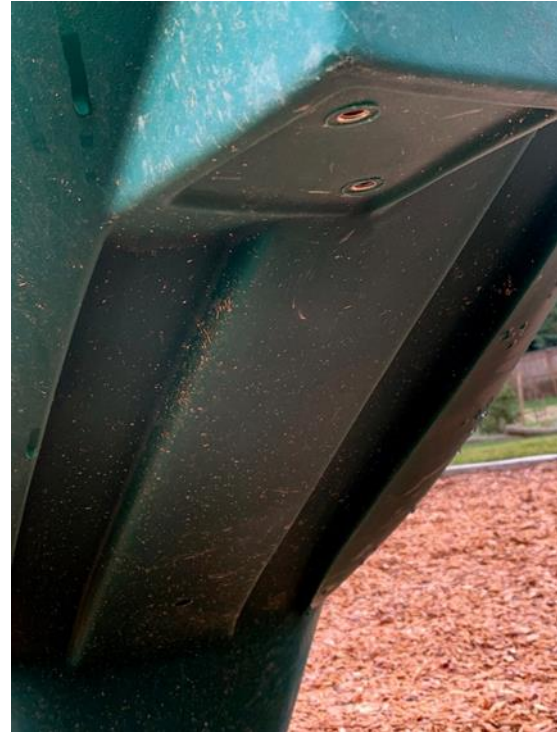
- **The slide oriented from West to East has a slight wobble, even before it has been played on. (see photos below)**
 - o The slide appears to have been designed to have a second support leg. I assume that is because the slide has a slight curve, and that second leg would be underneath the slide where it curves slightly.

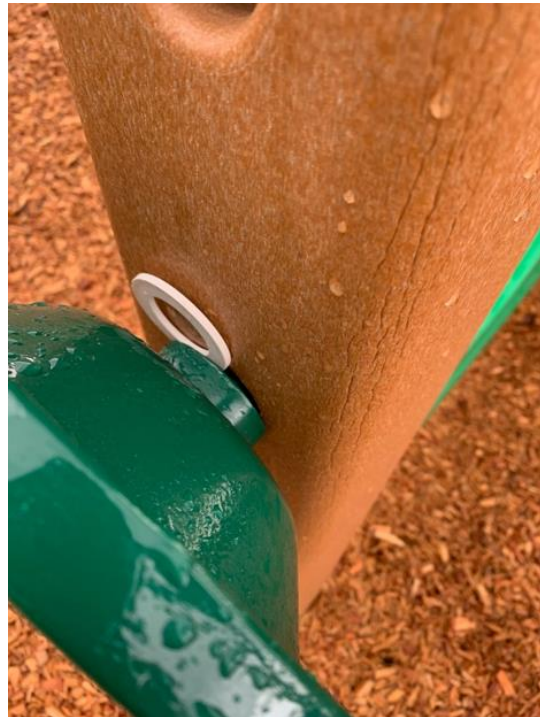
- **The steering wheel built into the composite structure is loose and wobbles significantly. (see photos and video below)**
 - o It is loose enough that my 1/8-inch gauge can fit between the post and the steering wheel. This could feasibly crush the finger on a small child. I do not know if a part is missing; or the wheel is just not tightened enough to remove the gap that is left.

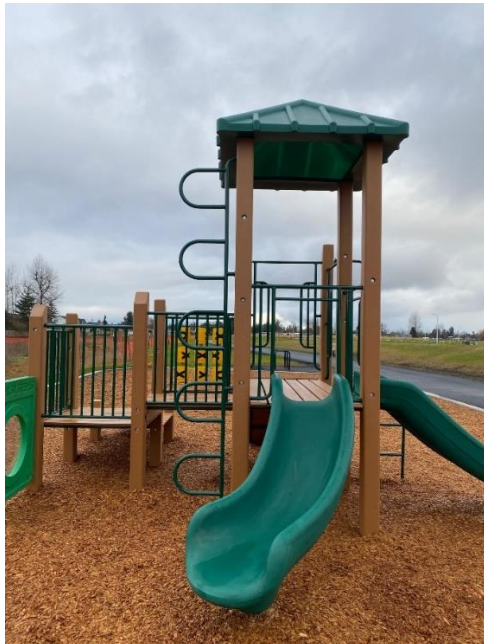
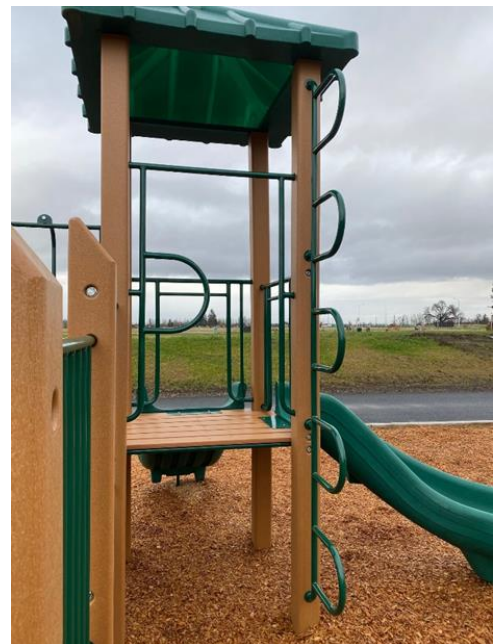
- **Engineered Wood Fiber and Safety Surfacing (see photos below)**

- Overall, the average depth of the engineered wood fiber appears to be **7 inches of uncompressed material**.
 - CPSI Requirement - 6 inches of uncompressed engineered wood fiber have a critical fall height protection of 6 feet (72 inches).

- CPSI Requirement - 9 inches of uncompressed engineered wood fiber would have critical fall height protection of 7 feet (84 inches).
 - CPSI Requirement - 12 inches of uncompressed engineered wood fiber would have critical fall height protection of greater than 12 feet (144 inches).

- **Safety Surfacing Deficiencies**
 - The larger arch rock-climbing structure has a critical fall height of 72 inches.
 - The tallest swings have a critical fall height of 96 inches.

- The climbing feature on the Southside of the composite climbing structure has a critical fall height of 118 inches.
 - The climbing feature actually gives a child access to the roof structure, so the height would actually be even higher than that. To meet critical fall height protection engineered wood fiber needs to be added to the play area.

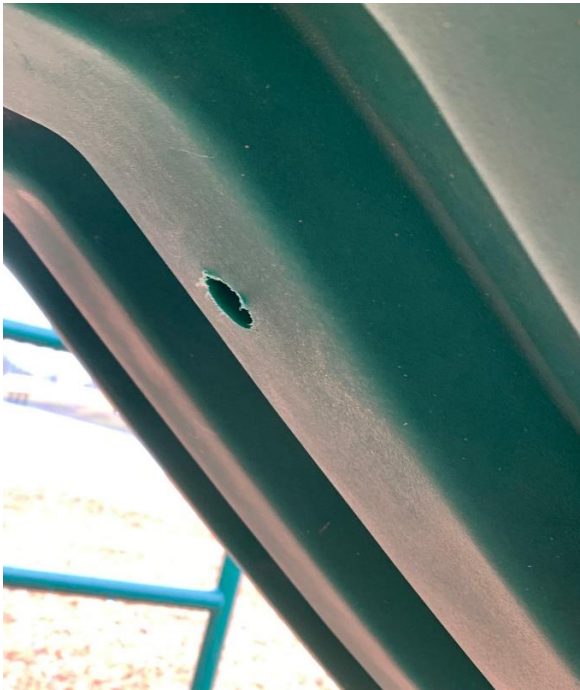
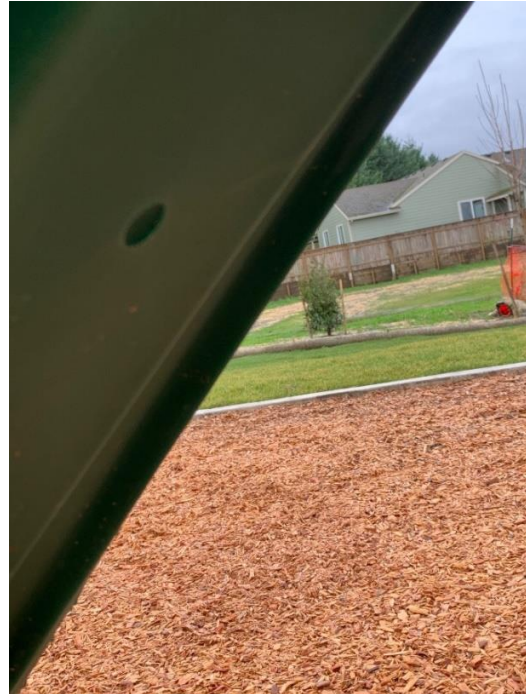
- **Play structure has open holes on the underside of the slides and roof. (see photos below)**
 - o These may serve a purpose for air movement and drainage, but they are also perfect holes for wasps and/or yellow jackets to make a nest. As well as kids sticking fingers and debris in these holes. I do not know if the ATSM standards address this issue but seems worthy of noting.

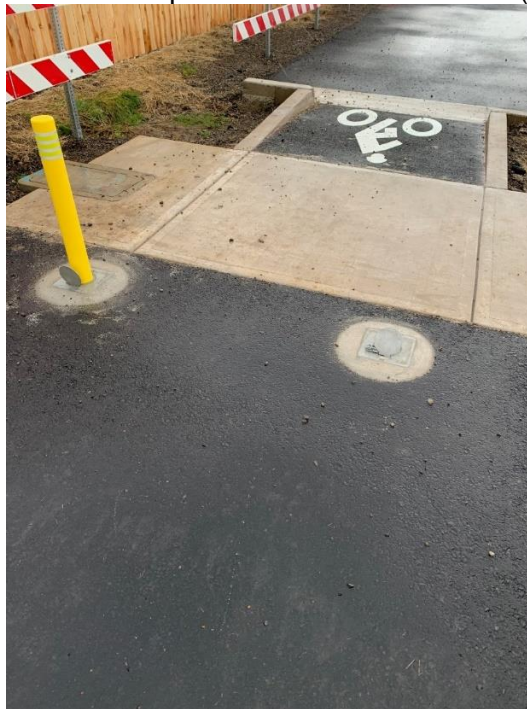
- Benches and bike racks through the park space that have been mounted in asphalt still wobble following developer tightening them.
- The bollard at the western end of the park is missing. The two bollards closest to the bathrooms are locked up in one of the bathrooms. (see photo below)
