Date: 04-14-2023

Address: 2385 Sprague Lane

Name: New Development

Type of Tree: Western Red Cedar

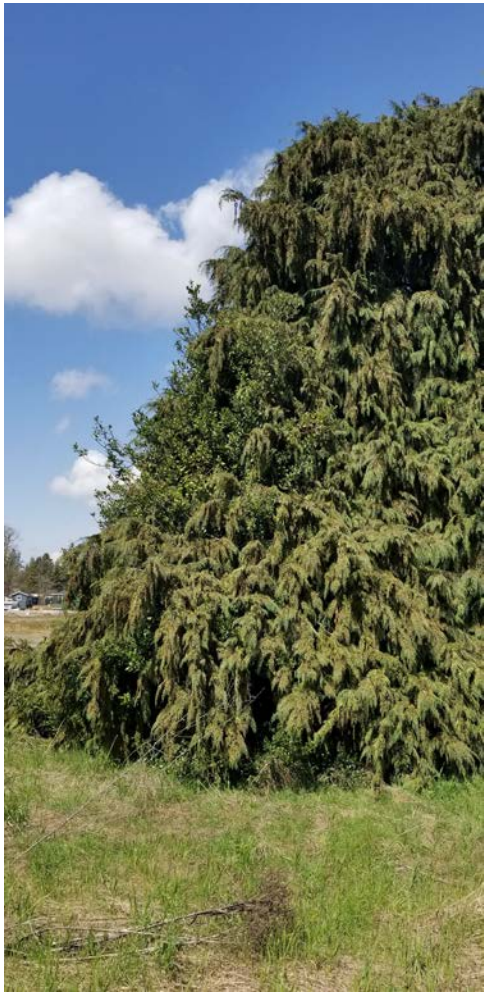
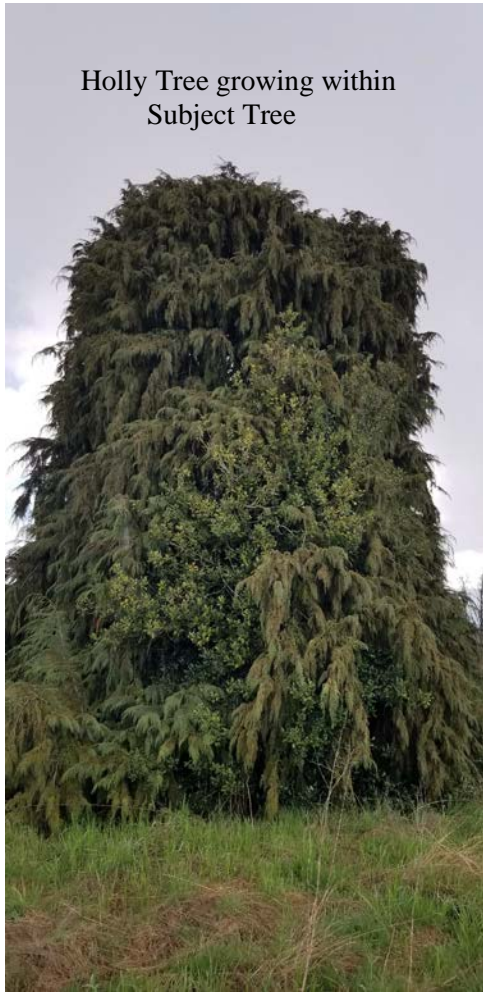
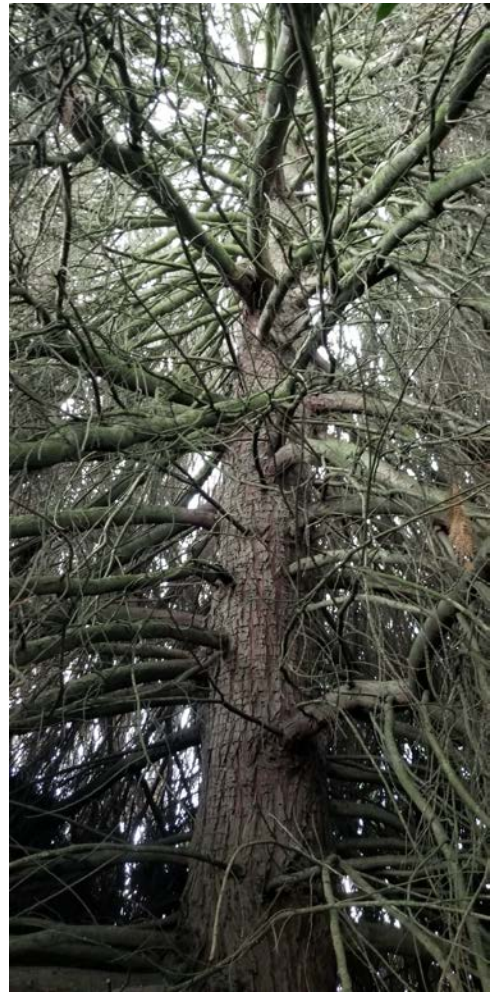
The tree seems to be in good health and is significant in size. 30" diameter approximately 35 feet tall. The structure of this tree is unique, the top of the tree looks like it was formed or shaped at a young age to eliminate the crown of the tree, sometimes the crown becomes irregular with age. The first half of the tree canopy branches reach the ground and make it difficult to get to the main trunk of the tree. Western Red Cedars are known to have shallow, wide-spreading and strong root systems. The subject tree has many small holes in the bark which could've been caused by borers or woodpeckers. I suggest consulting with a Certified Arborist about the presence of the tiny holes. If this is a severe infestation of beetles, the tree could be evaluated as a risk and recommended for removal. There is a Holly tree established approximately 10 feet from the subject tree that is recommended to be removed. See photos below of subject tree.

Depending on Development Plans and Building Locations. If the property owner wanted access to the main trunk, it would be challenging to prune the tree with the existing branch structure and make it appealing. If left alone and left as-is, it will be difficult to access the main trunk of the tree. My concerns are the tiny holes throughout the tree. However, if these are found to be a non-health issue and it fits within the development plans, the developer would be able to leave the tree.

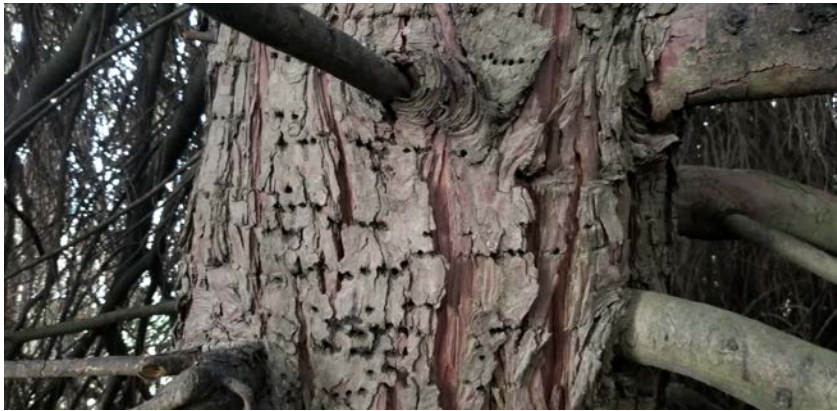
Tiny holes throughout the main trunk

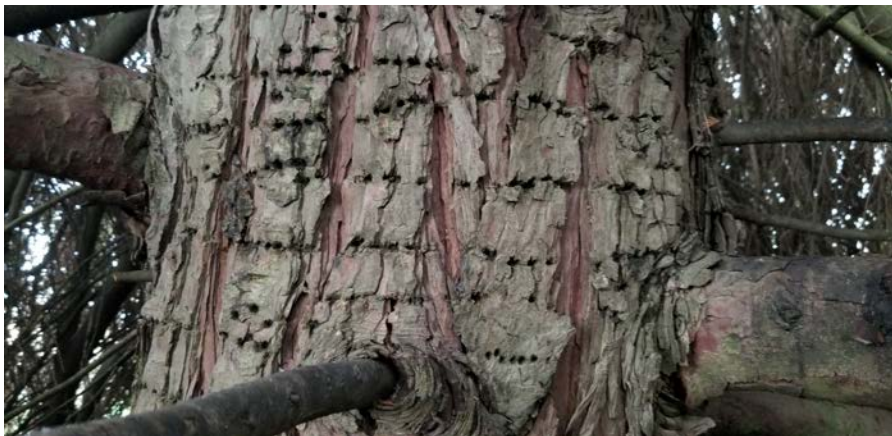
Common Western Cedar Crown Shape

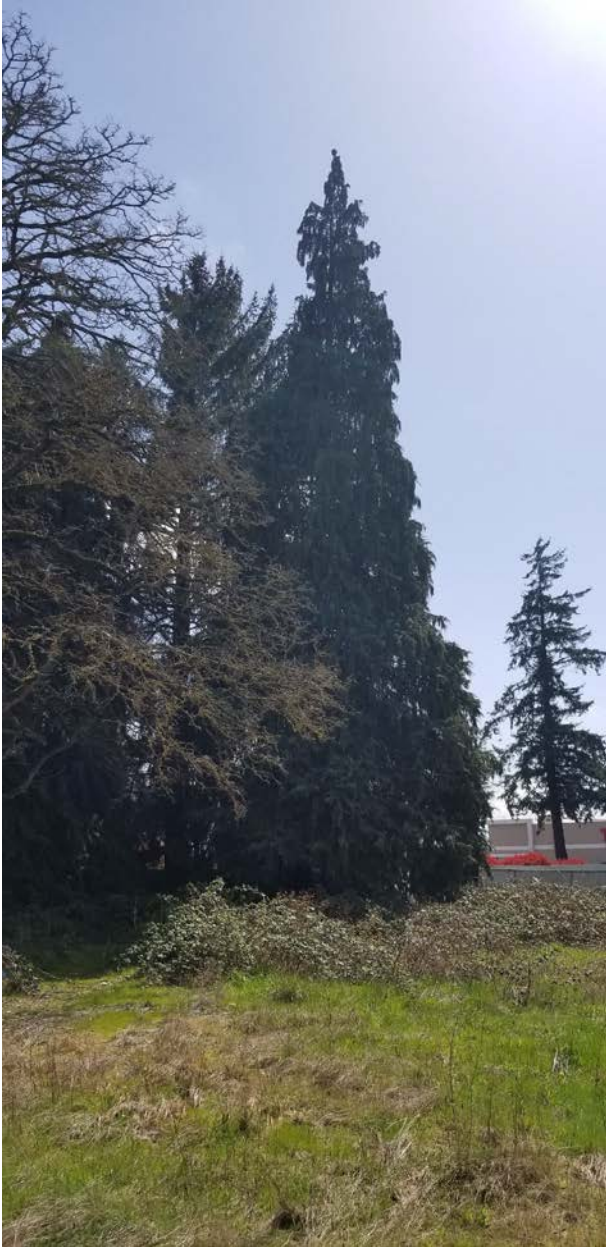
Subject Tree Crown Shape
