WOODBURN MUSEUM & THEATER REROOF & SEISMIC UPGRADE
ADDENDUM #1

January 04, 2019

Project Number: 12089

ROOF INSPECTION REPORT

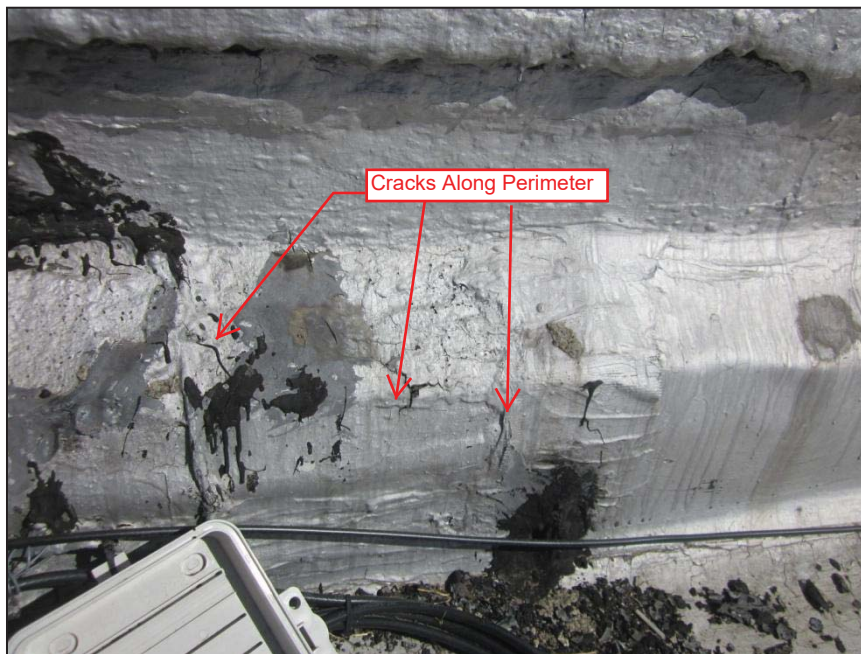
- b. The exception is the north perimeter at Roof A. This is a brick wall with membrane and aluminum coating and it is considered to be in fair condition and is a potential future interior leakage problem.

Sec. 1.02 – Roof A: View typical cracks in coating and membrane at the north perimeter.

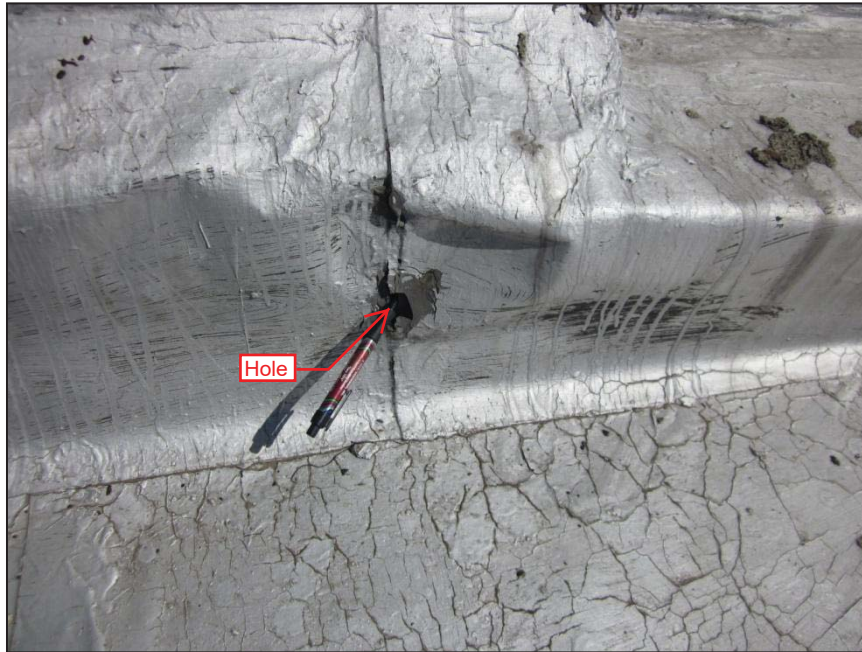
Sec. 1.03 – Roof A: View of hole in base flashing at north perimeter at the northeast section of the roof.

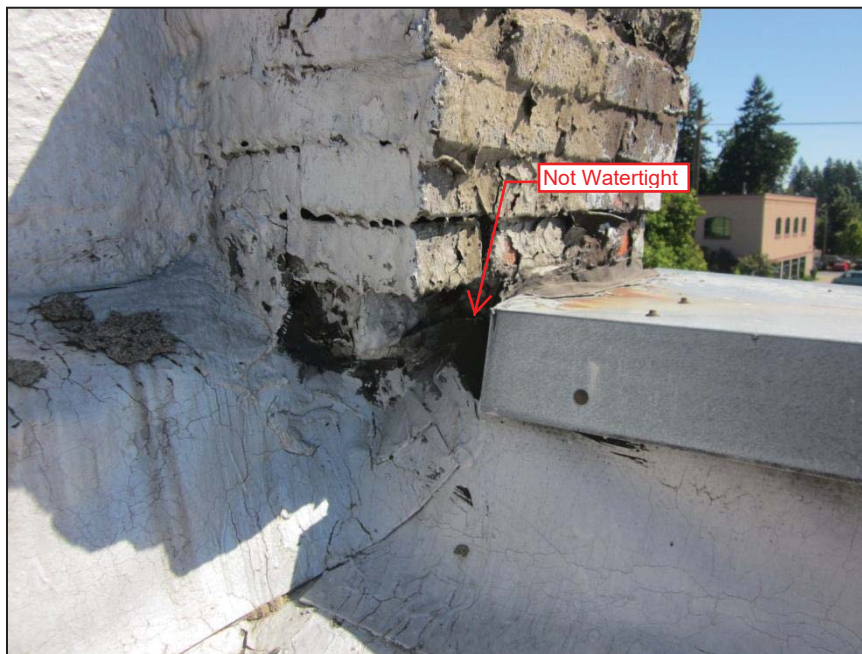
Sec. 1.04 – Roof A: View base flashing that is not watertight at the northeast corner of the roof.

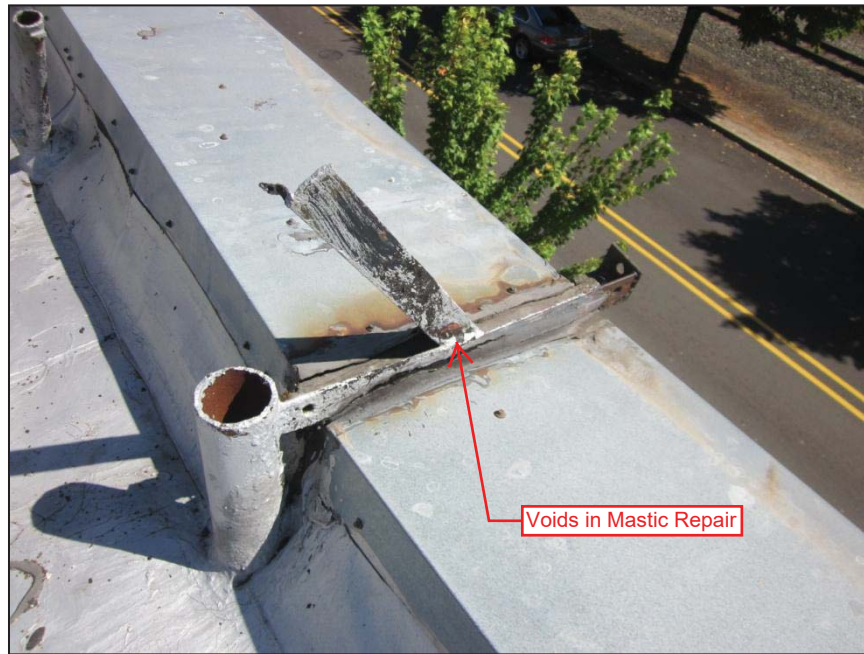
- a. Perimeter Sheet Metal System: Voids in previous mastic repairs at a few locations at the south and east parapets. This is considered a potential future interior leakage problem.
(1) **Action:** Inspect sheet metal and repair as required. *(contractor item)*
- b. Base Flashing: Holes and splits in previous mastic repairs at north parapet at northeast section of the roof. This is considered a potential future interior leakage problem.
(1) **Action:** Inspect base flashing and repair as required. *(contractor item)*

Sec. 1.05 – Roof A: View of typical void in previous mastic repair at metal coping joint at the east parapet.

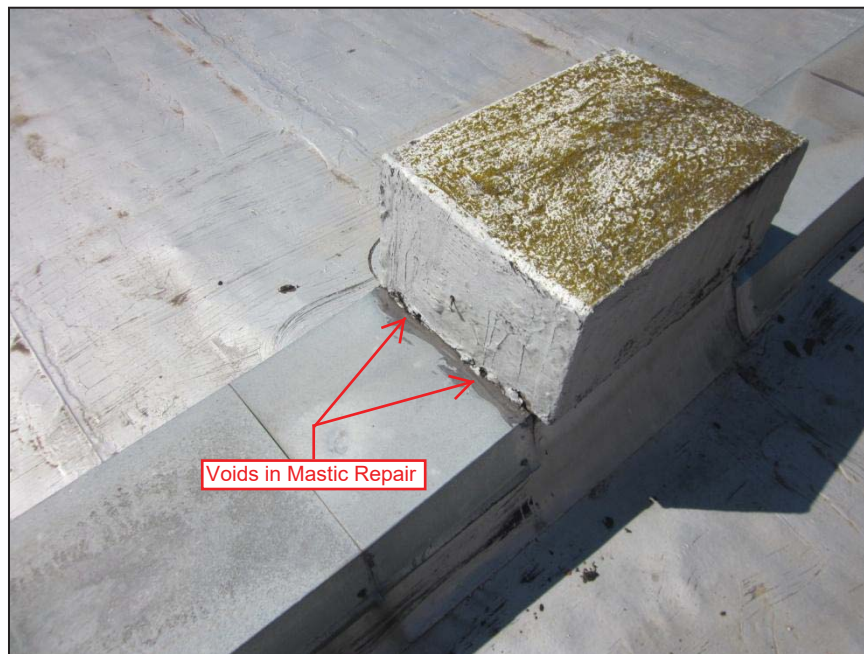
Sec. 1.06 – Roof A: View of void in previous mastic repair at metal coping at south parapet at the southwest section of the roof.

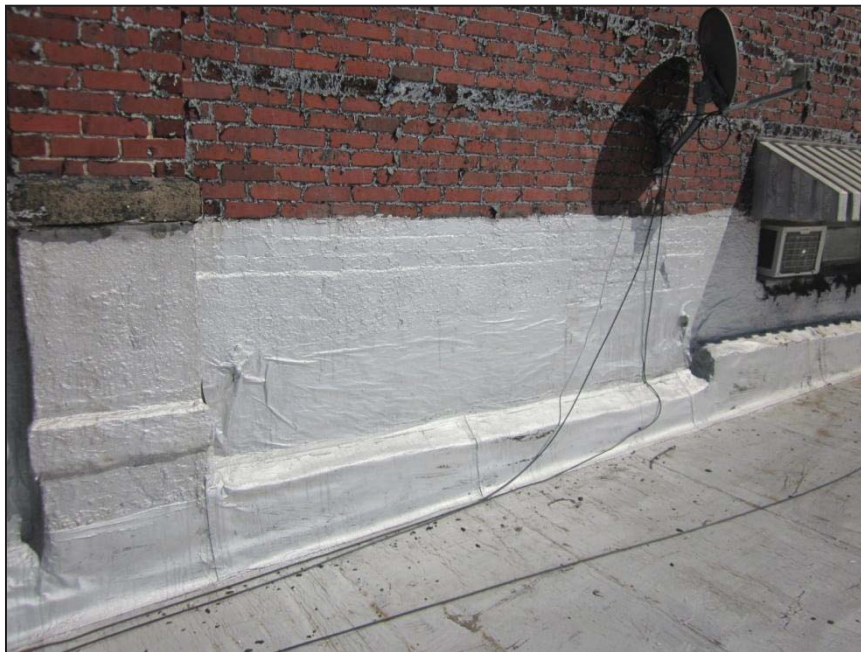
Sec. 1.08 – Roof A: View typical membrane and coating at the north perimeter.

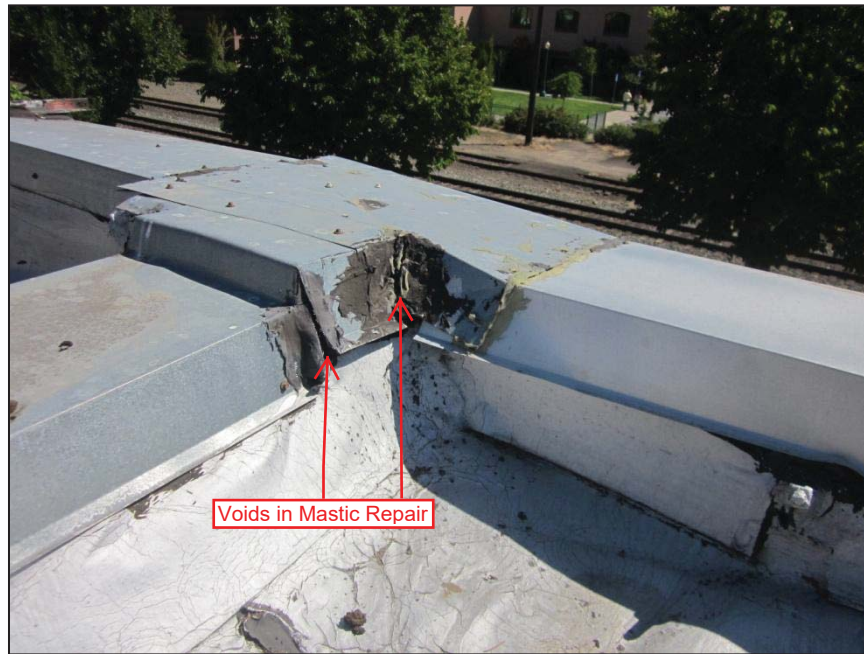
- a. Perimeter Sheet Metal System: Voids in previous mastic repairs at northeast corner of the roof. This is considered a potential future interior leakage problem.
(1) **Action:** Inspect sheet metal and repair as required. *(contractor item)*
- b. Vents: Voids and splits in previous mastic repairs at base of vents at west section of the roof. This is considered a potential future interior leakage problem.
(1) **Action:** Inspect base flashing and repair as required. *(contractor item)*

Sec. 1.09 – Roof B: View of voids in previous mastic repair to metal coping at the northeast corner of the roof.

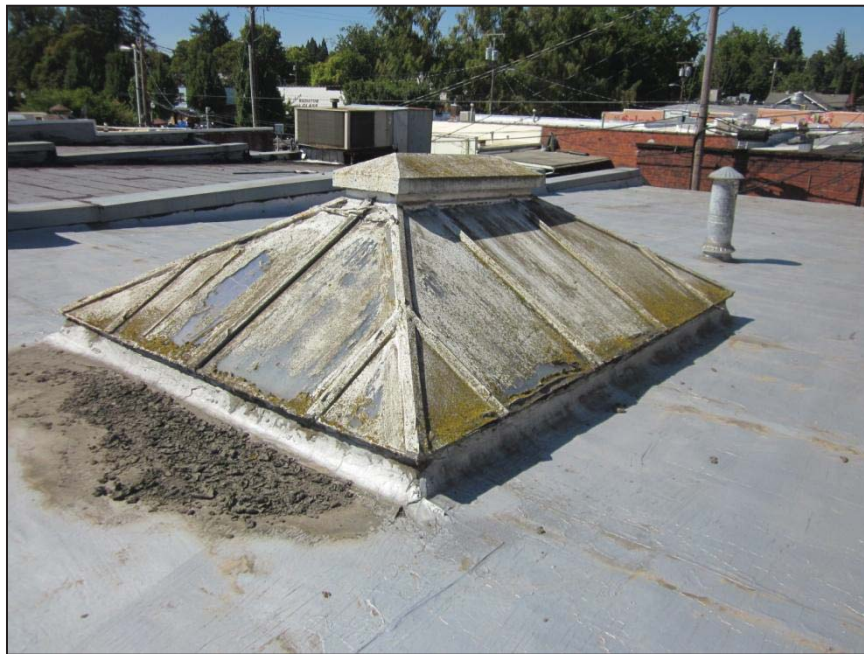
Sec. 1.10 – Roof B: View of skylight that has splits in membrane at base of skylight.

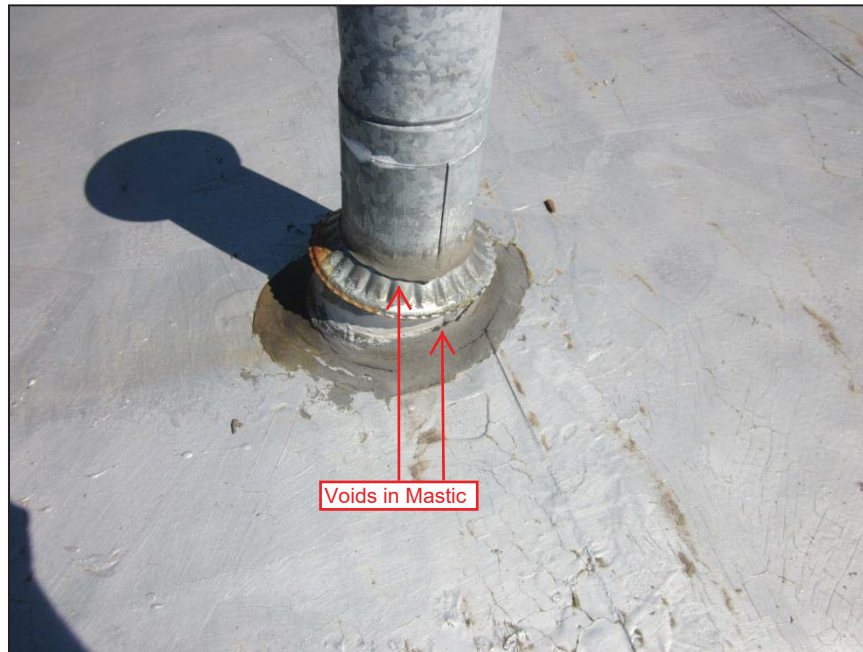
Sec. 1.11 – Roof B: View of voids in mastic repair at base of vent at the west section of the roof.
