APPENDIX B

Collection System Condition Mapping

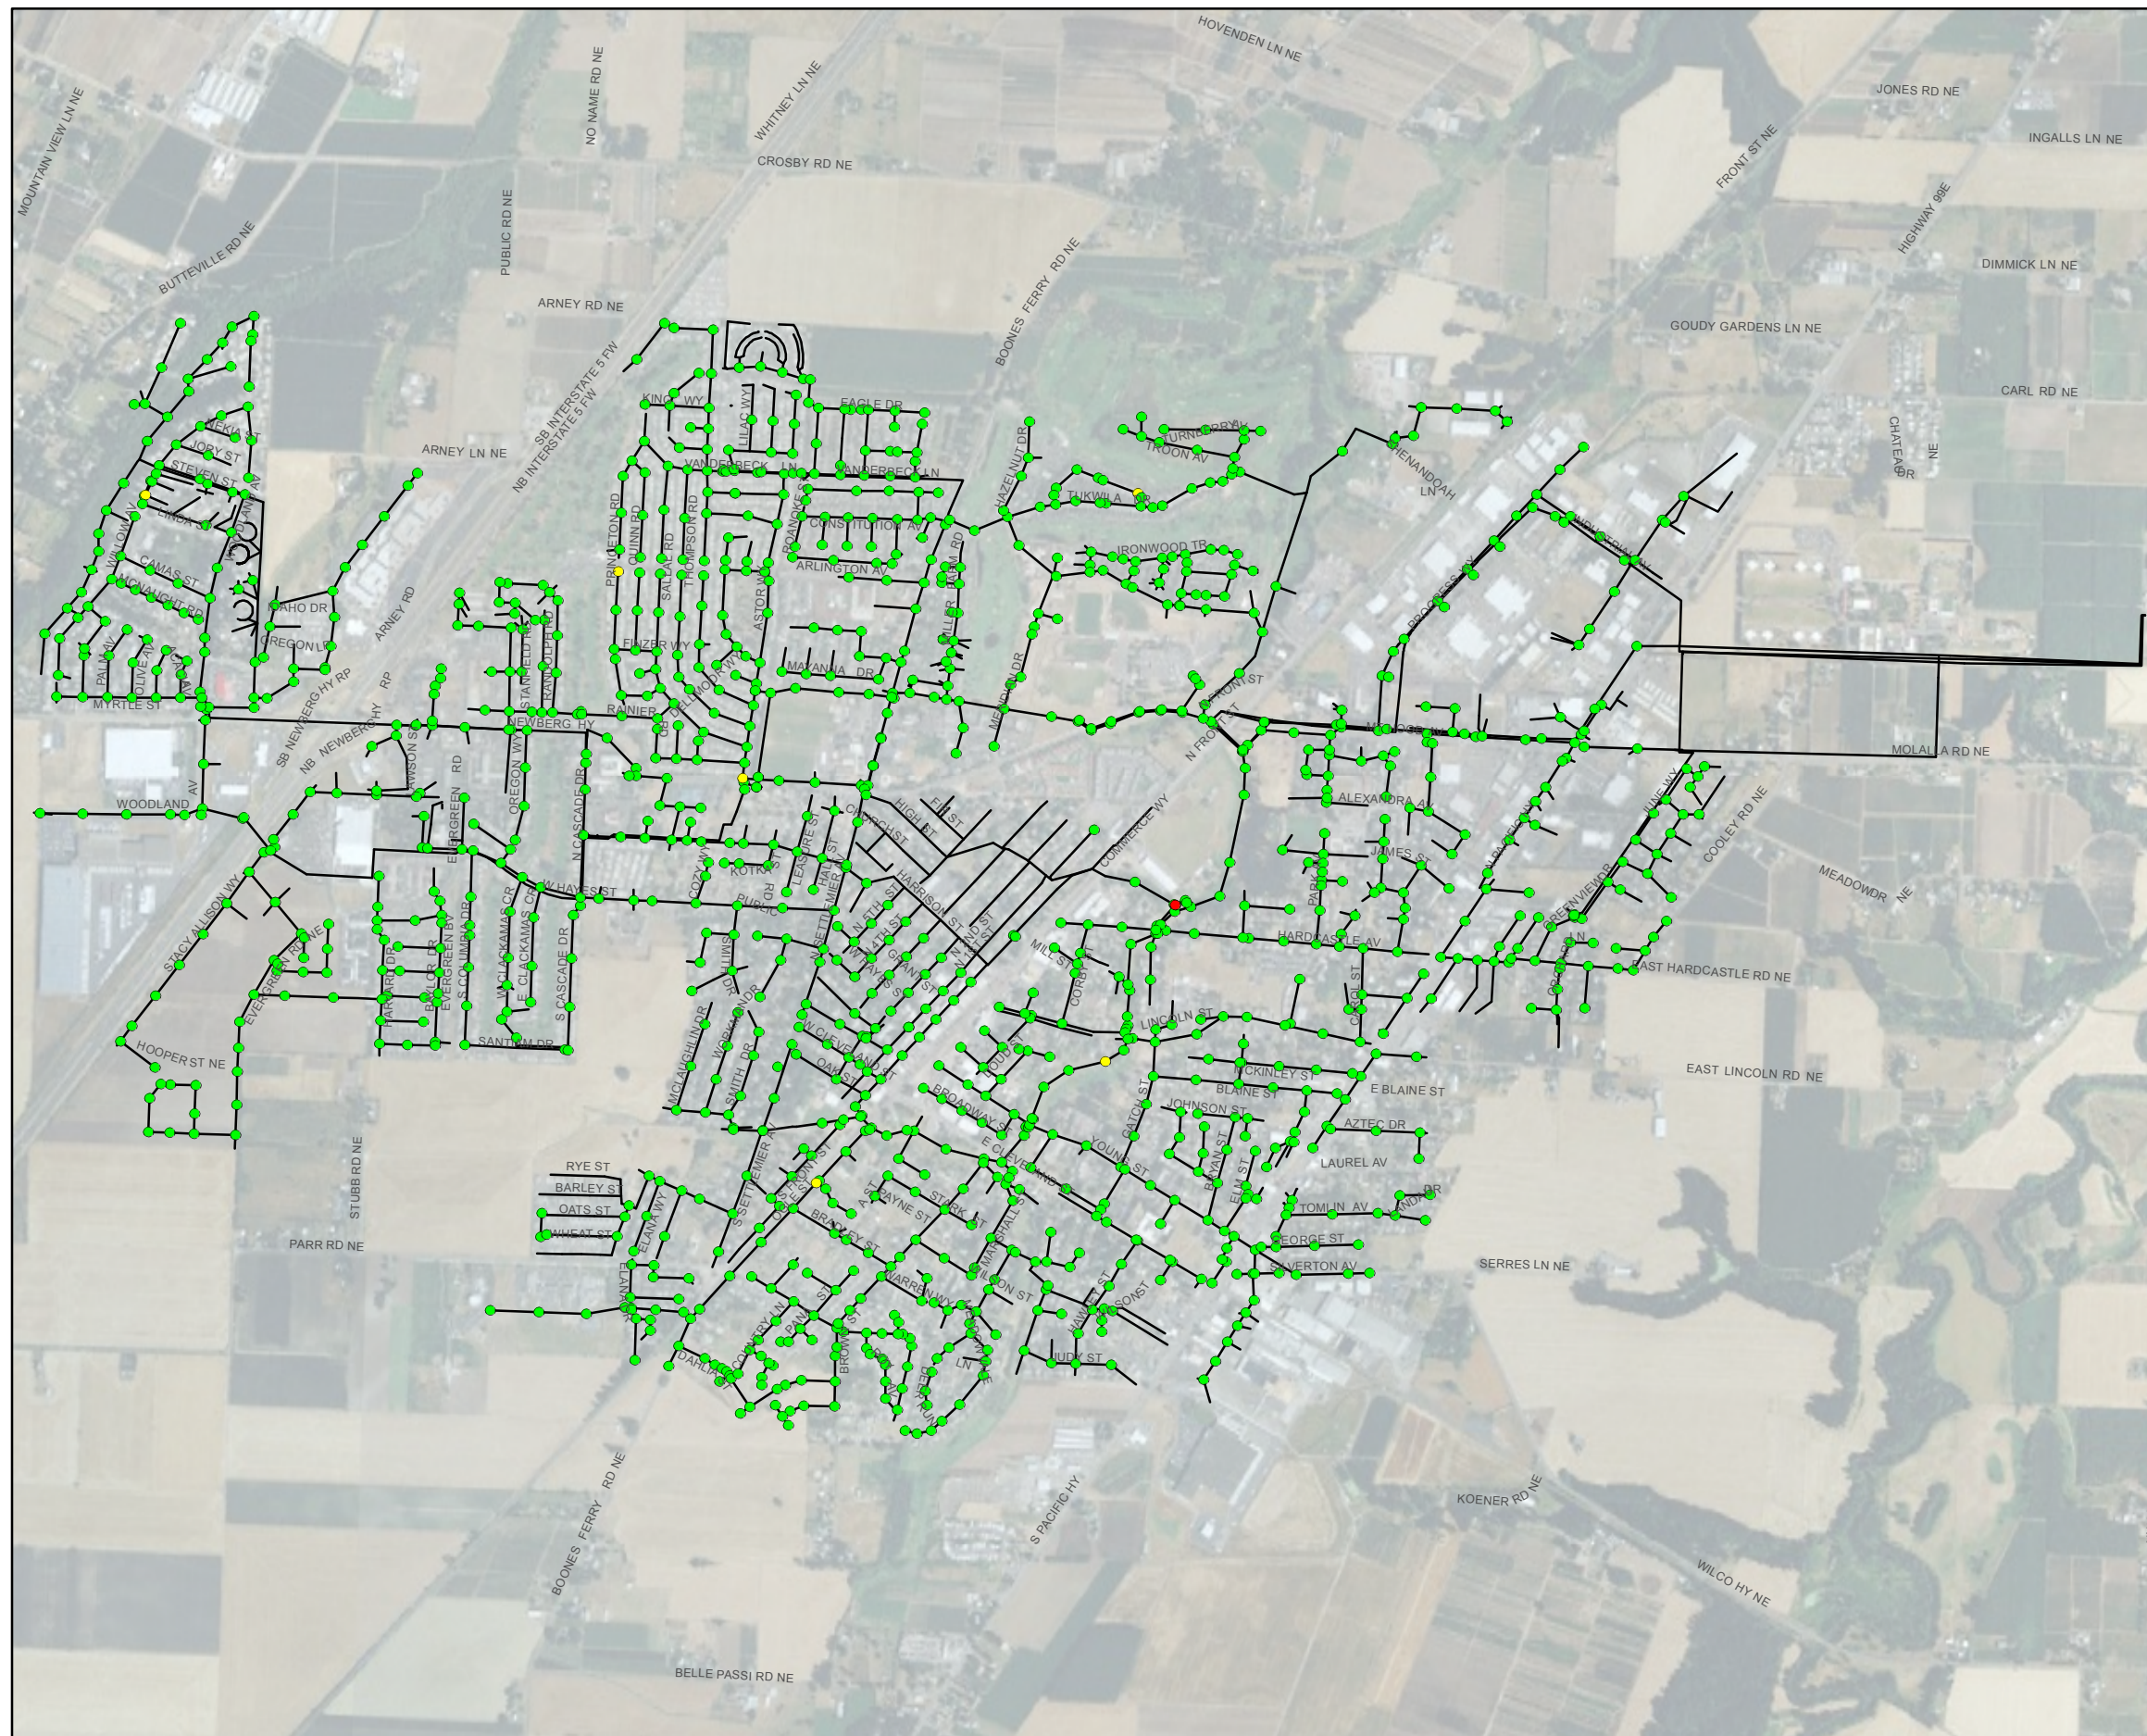
FIGURE B-1
CH2M Hill Survey MH Observations -
Cover
 Woodburn

- LEGEND**
- Cover Condition**
- Broken (1)
 - Cracked (6)
 - Good (1291)
- Collection Sytem Pipe

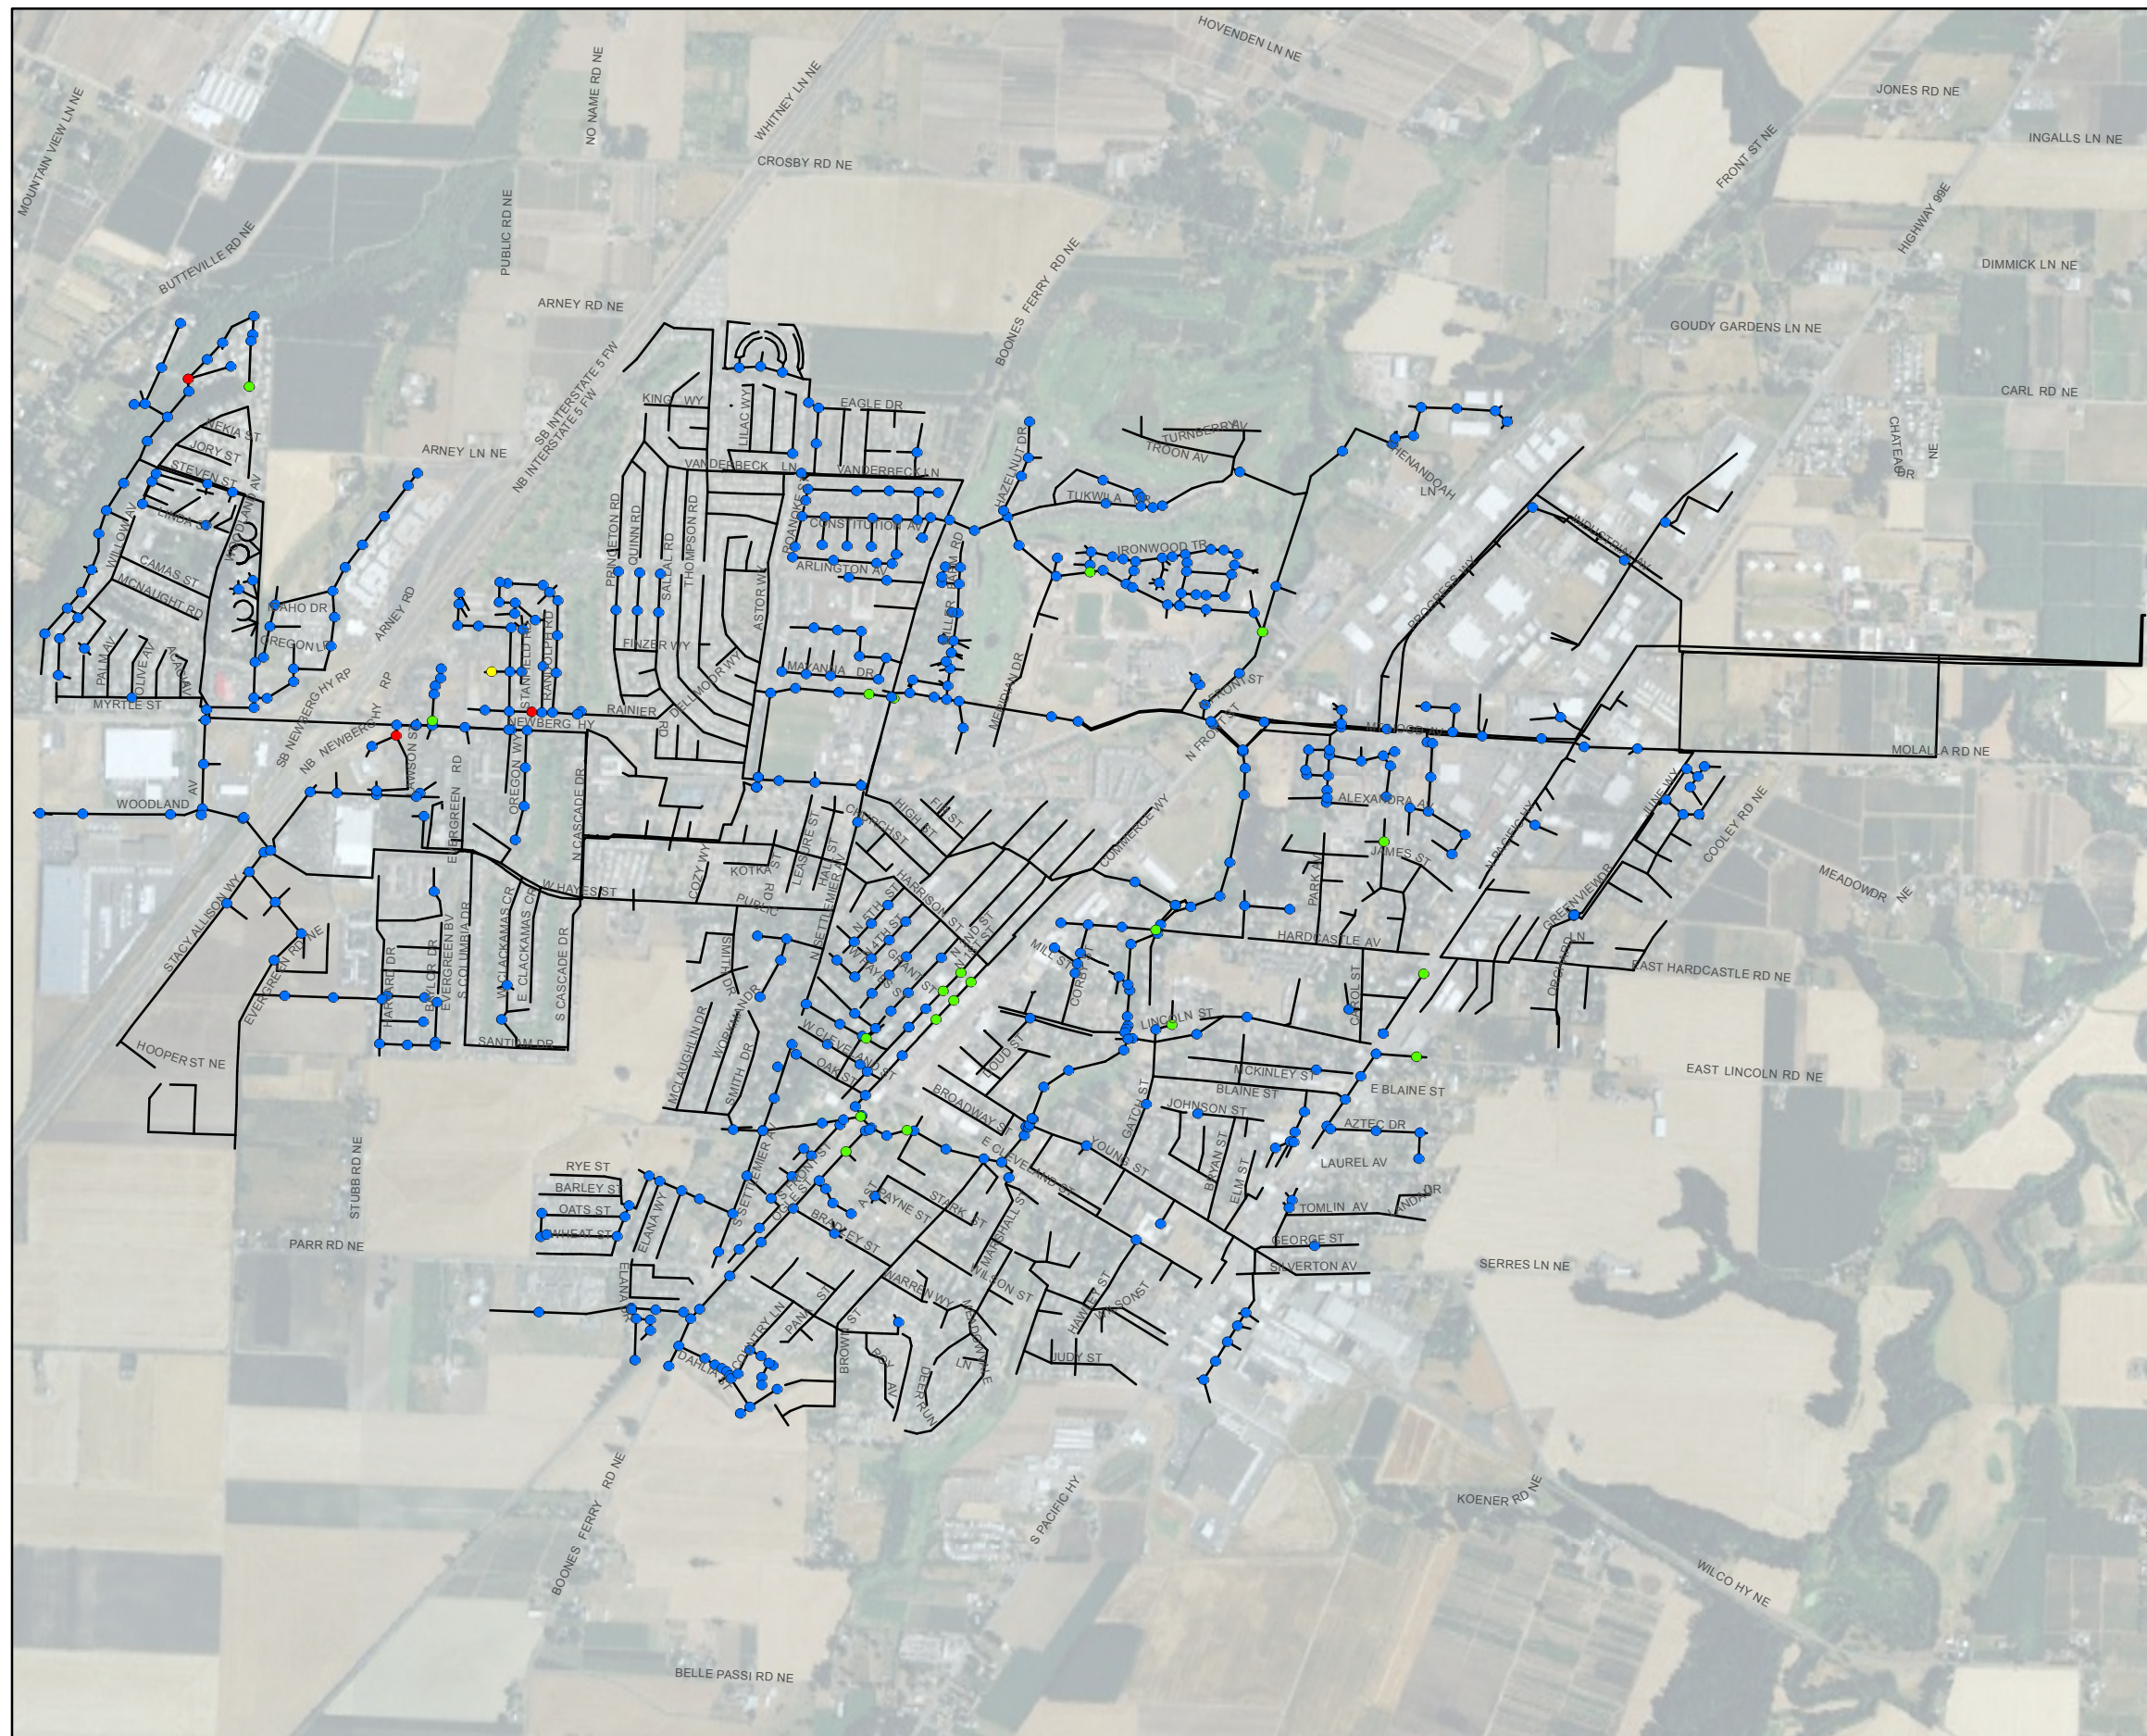
FIGURE B-2
CH2M Hill Survey MH Observations -
Corrosion
 Woodburn

- LEGEND**
- Corrosion**
- Exposed Aggregate (3)
 - Exposed Rebar (1)
 - Rough Surface (21)
 - None (504)
- Collection System Pipe

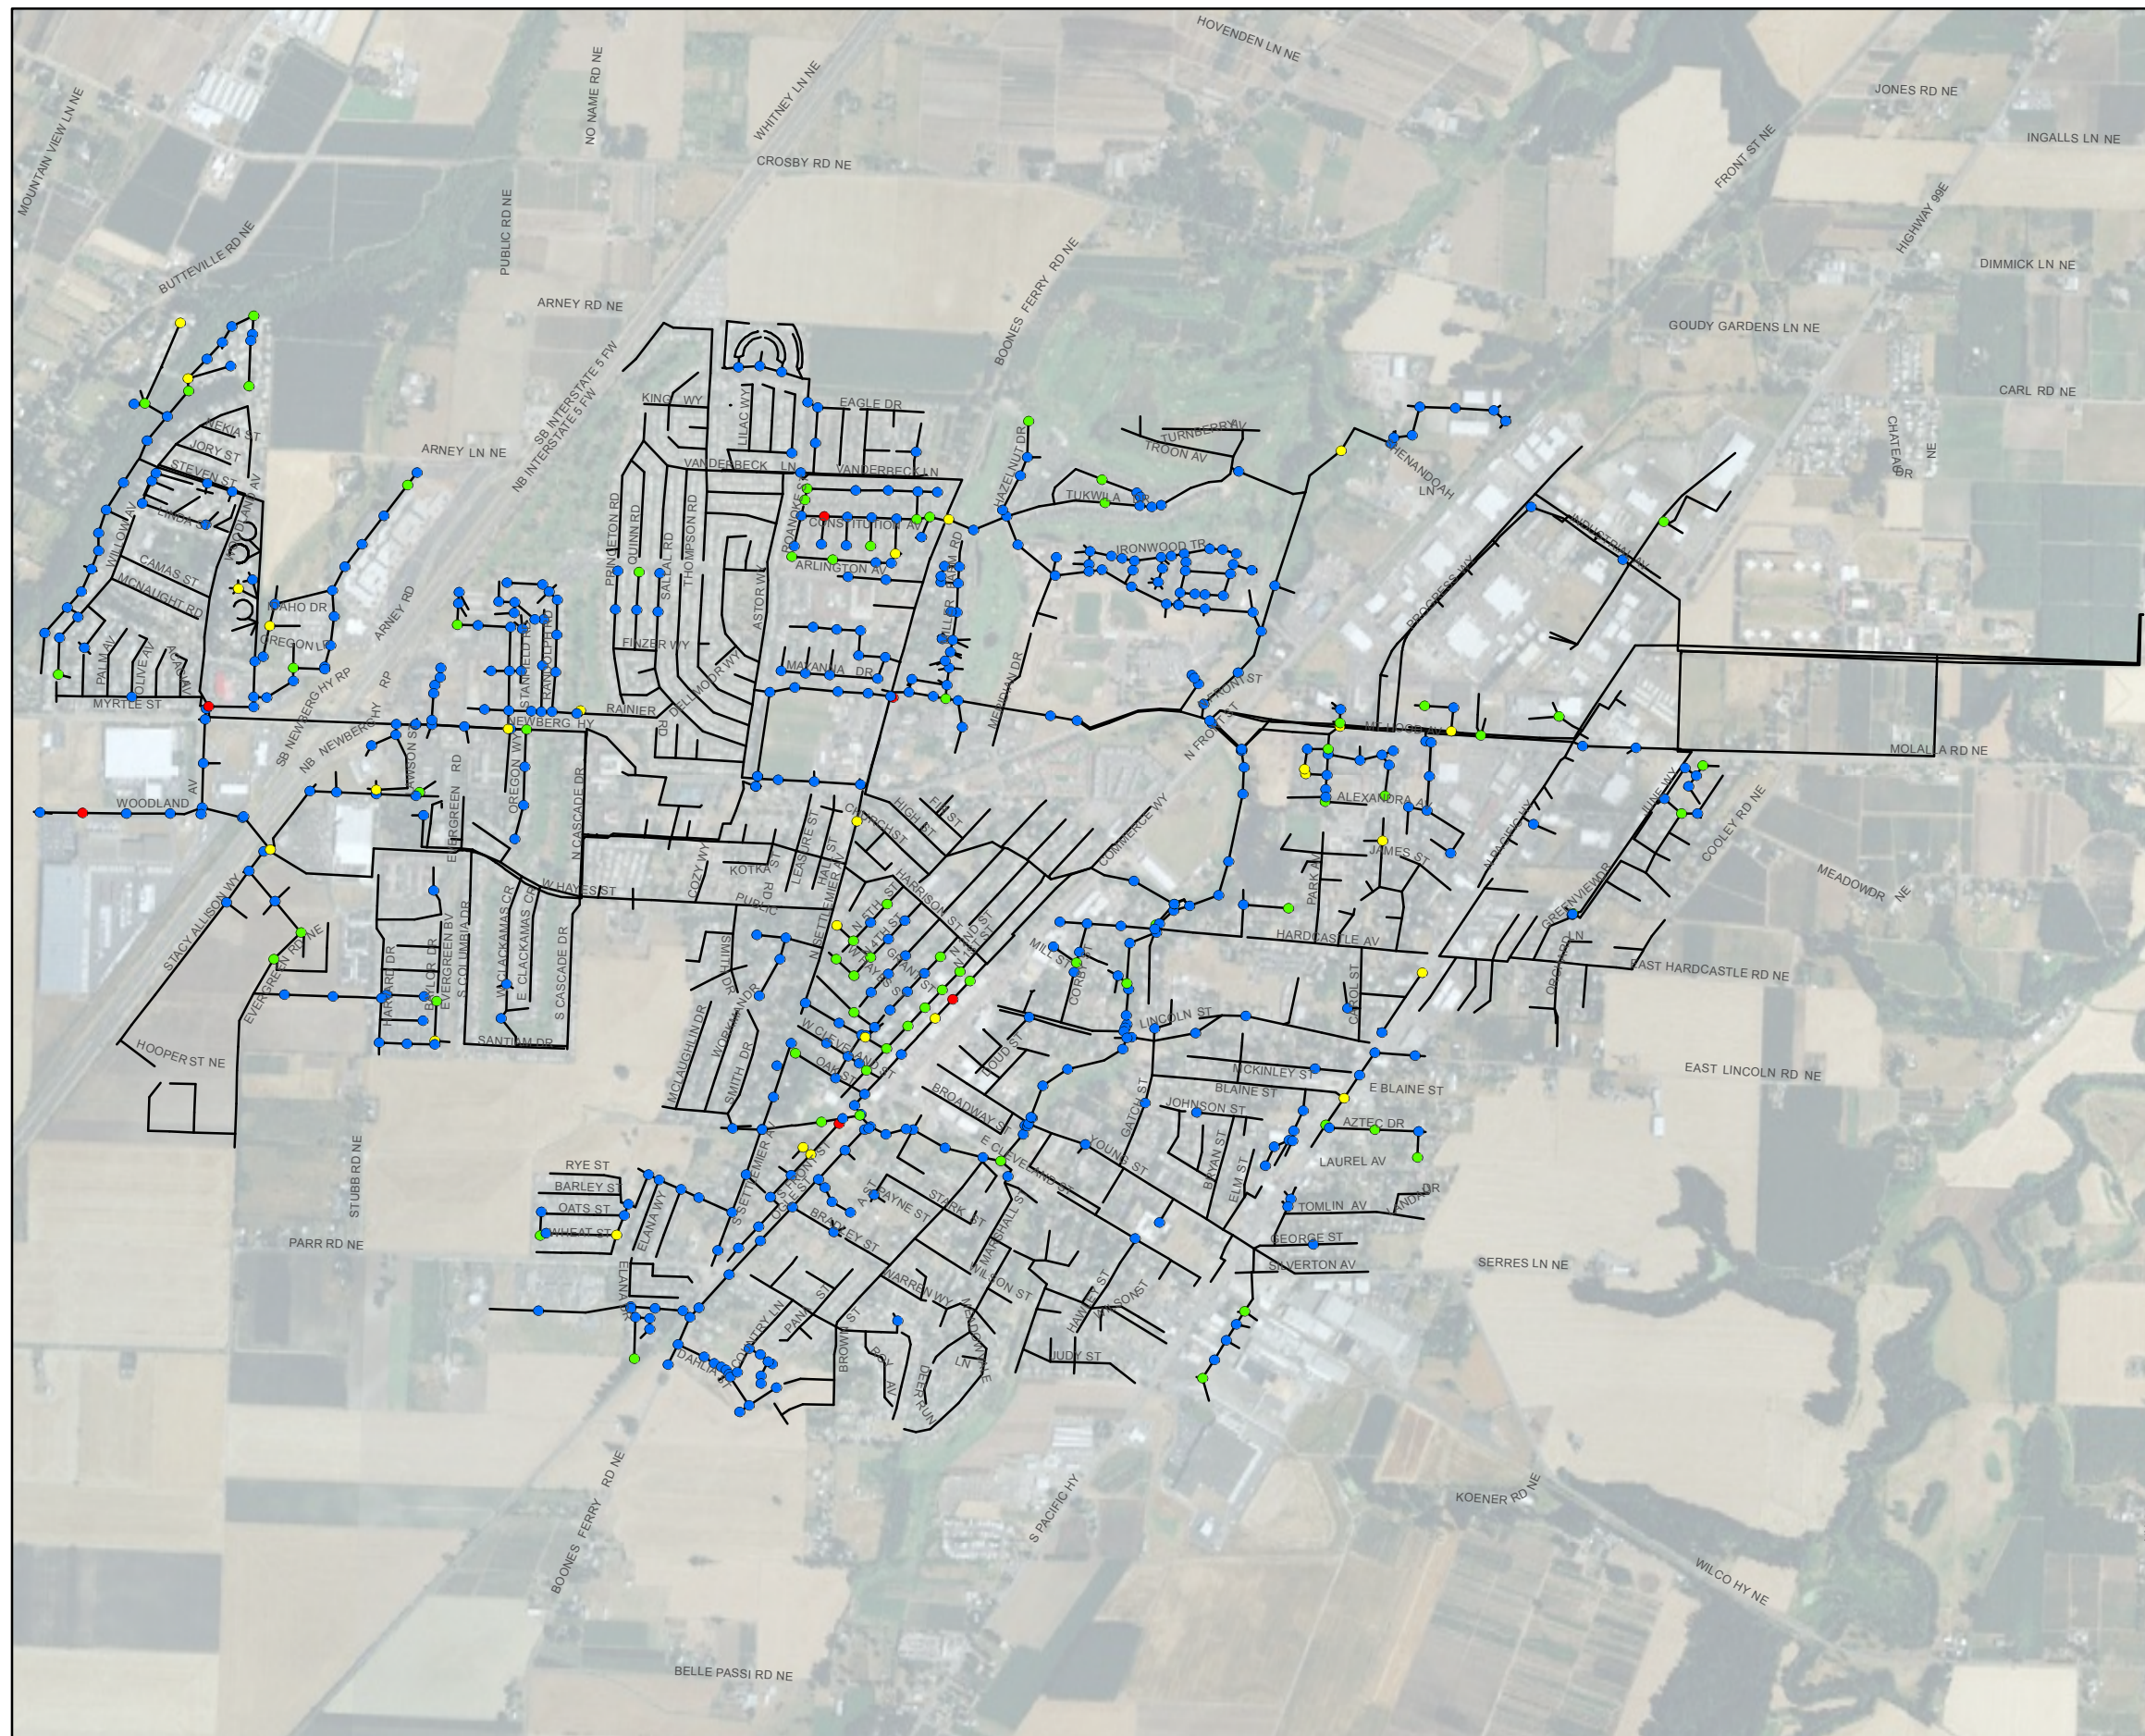
FIGURE B-3
CH2M Hill Survey MH Observations -
Corrosion
 Woodburn

- LEGEND**
- Debris**
- Heavy (6)
 - Medium (26)
 - Light (66)
 - None (442)
- Collection System Pipe

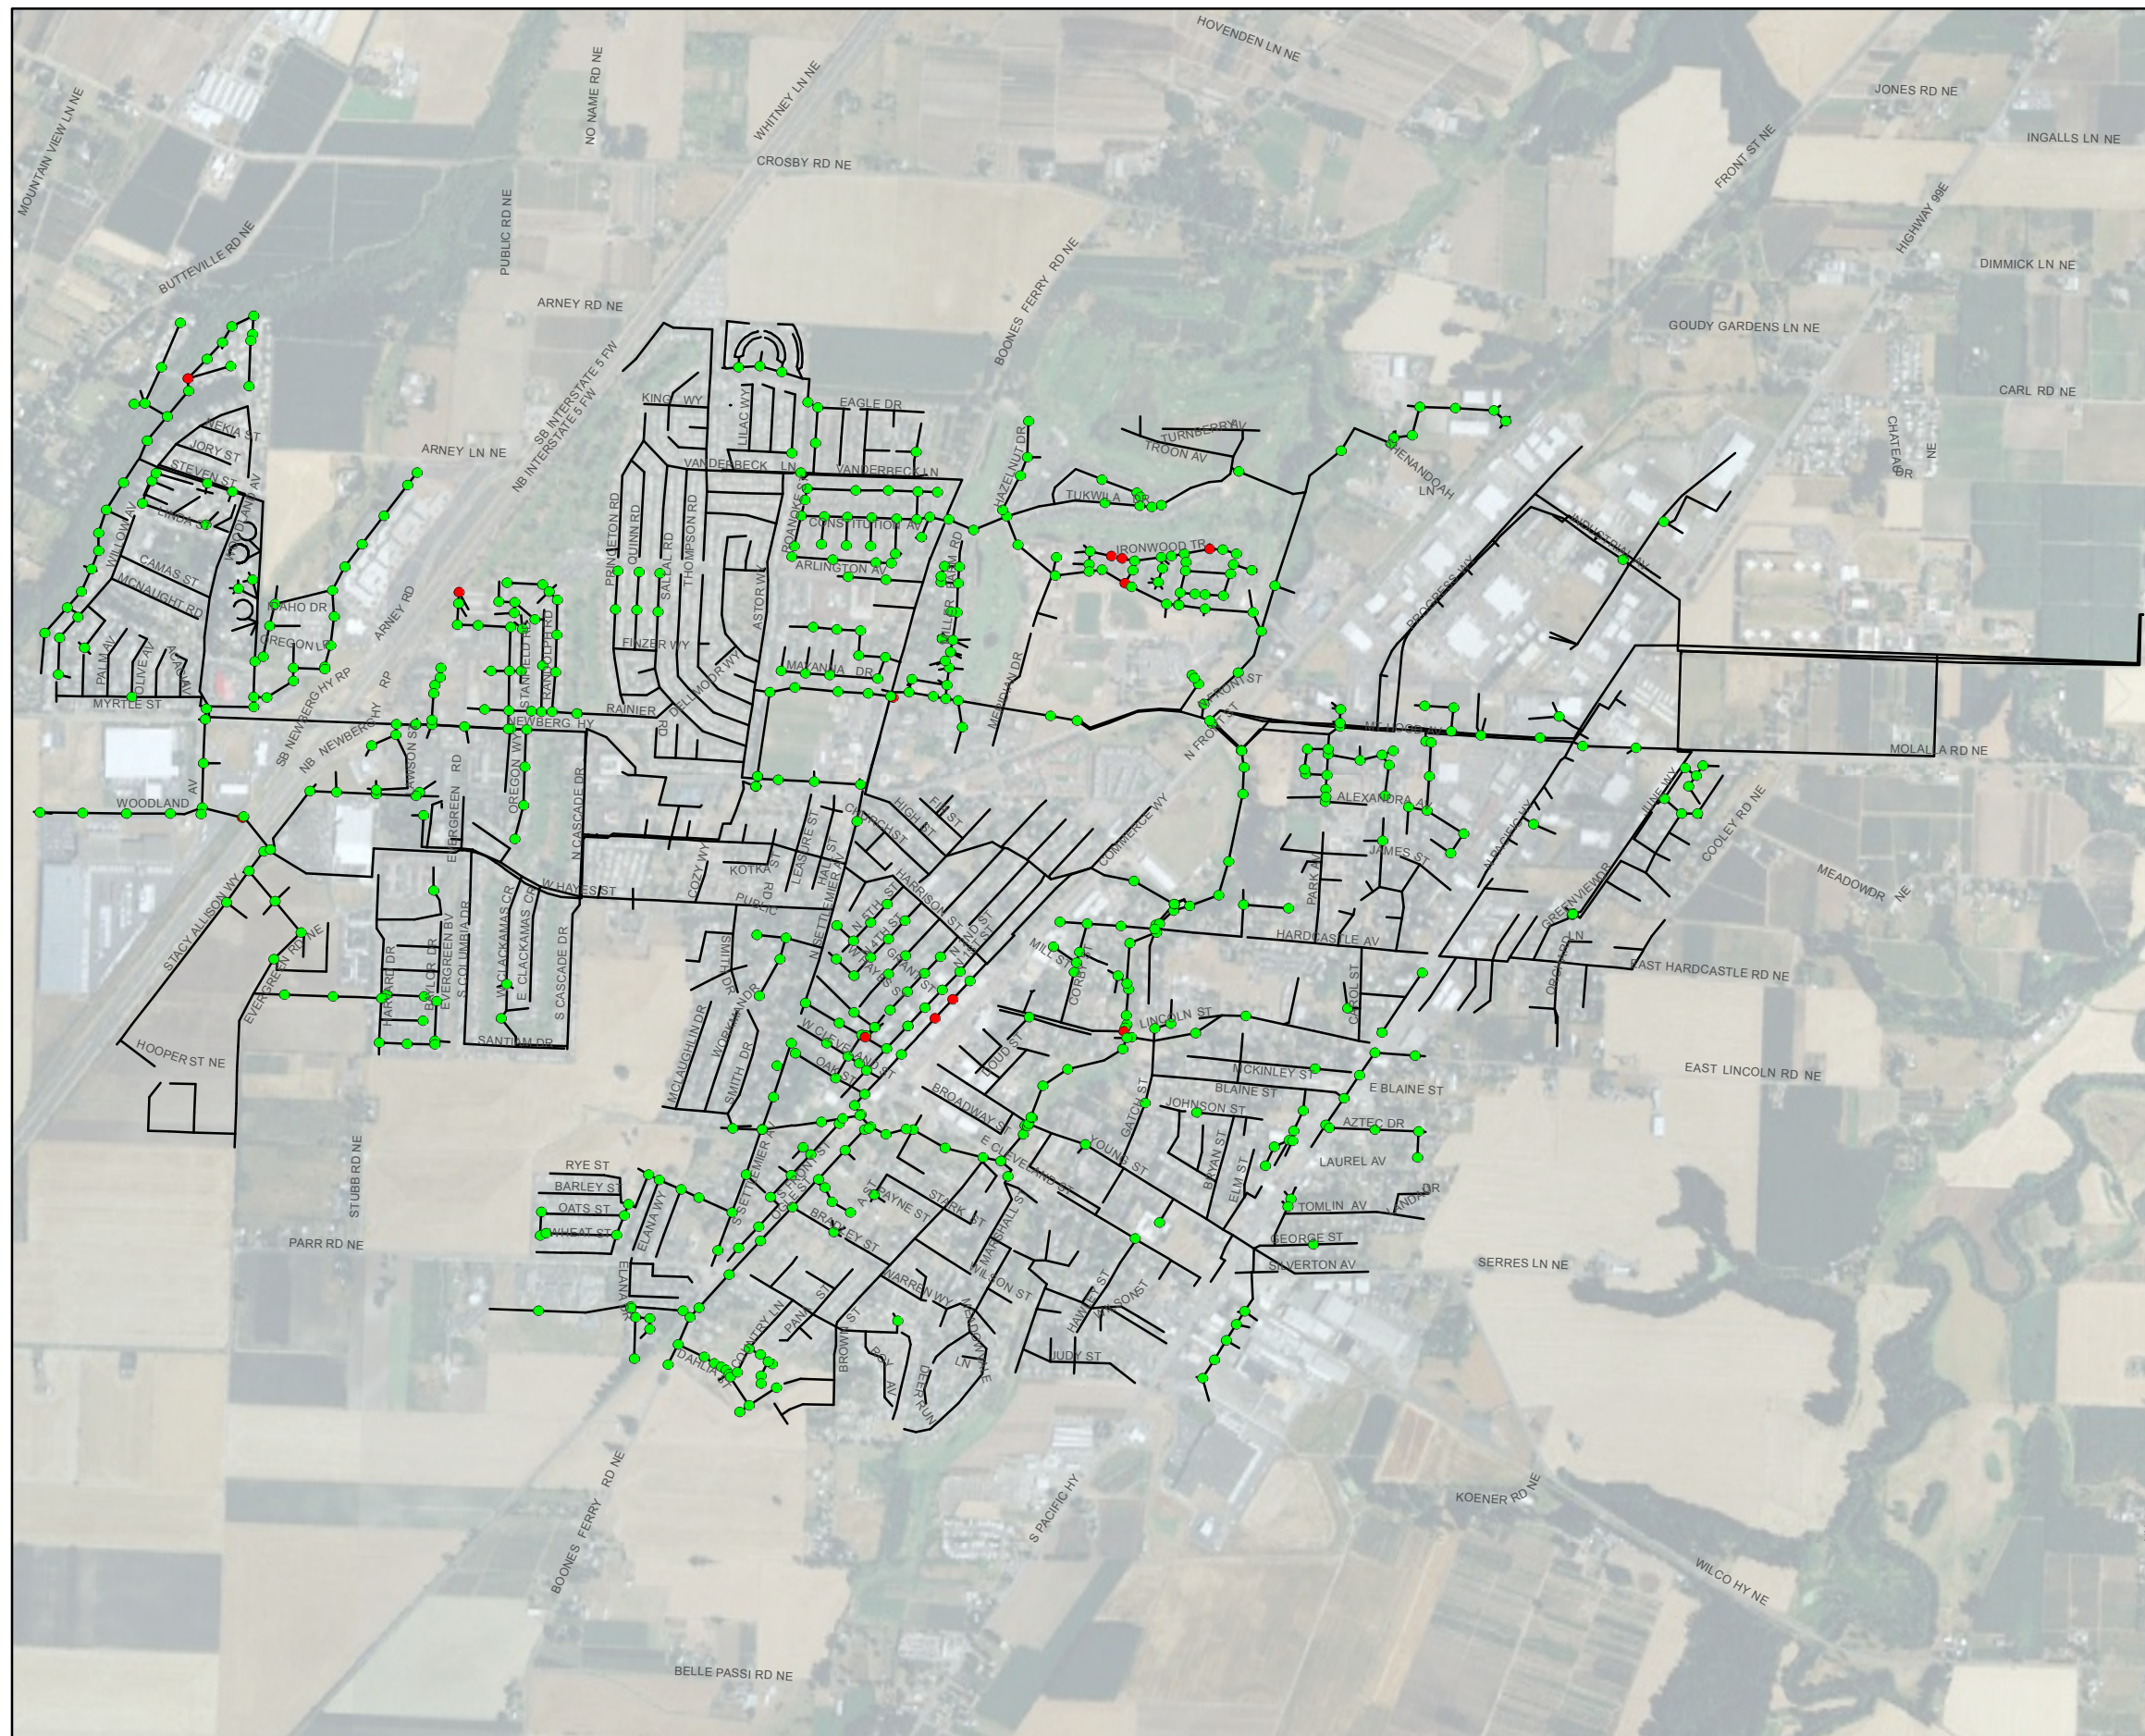
FIGURE B-4
CH2M Hill Survey MH Observations -
Invert
 Woodburn

- LEGEND**
- Invert Condition**
 - Damaged (12)
 - Smooth (527)
 - Collection System Pipe

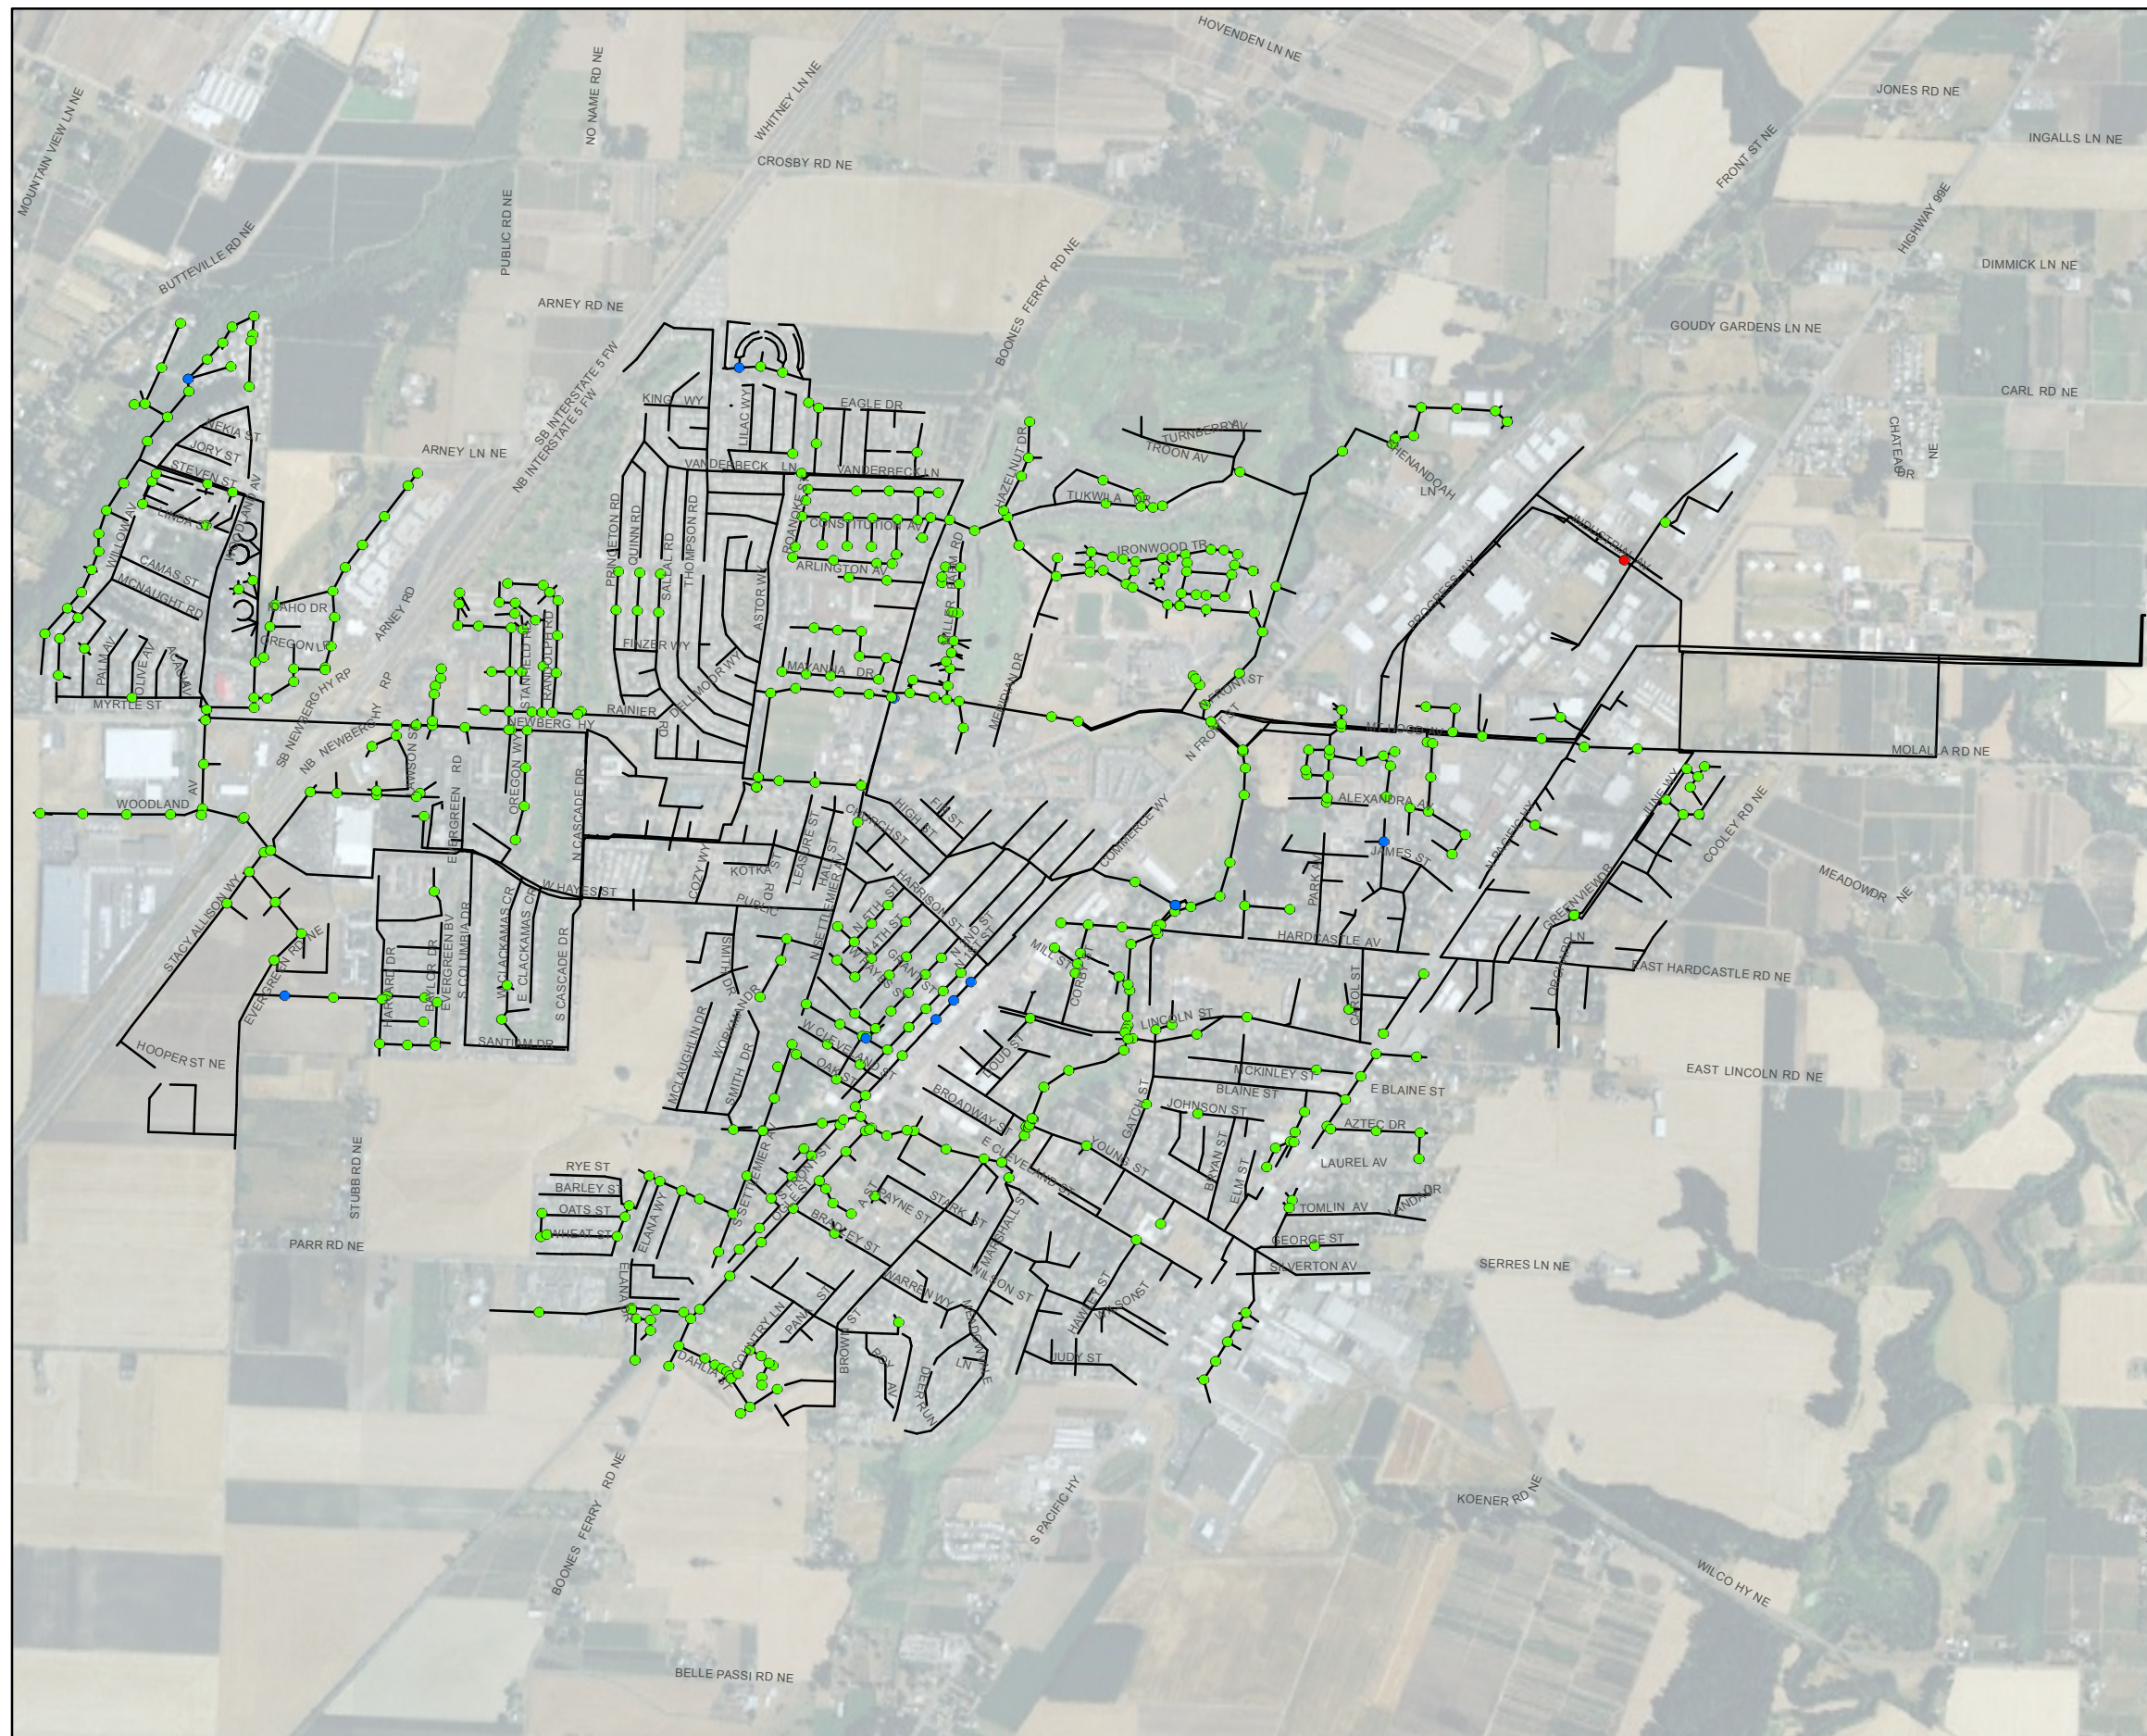
FIGURE B-5
CH2M Hill Survey MH Observations -
Barrel
 Woodburn

- LEGEND**
- Barrel Condition**
- Good
 - Fair
 - Force Main
 - Collection System Pipe

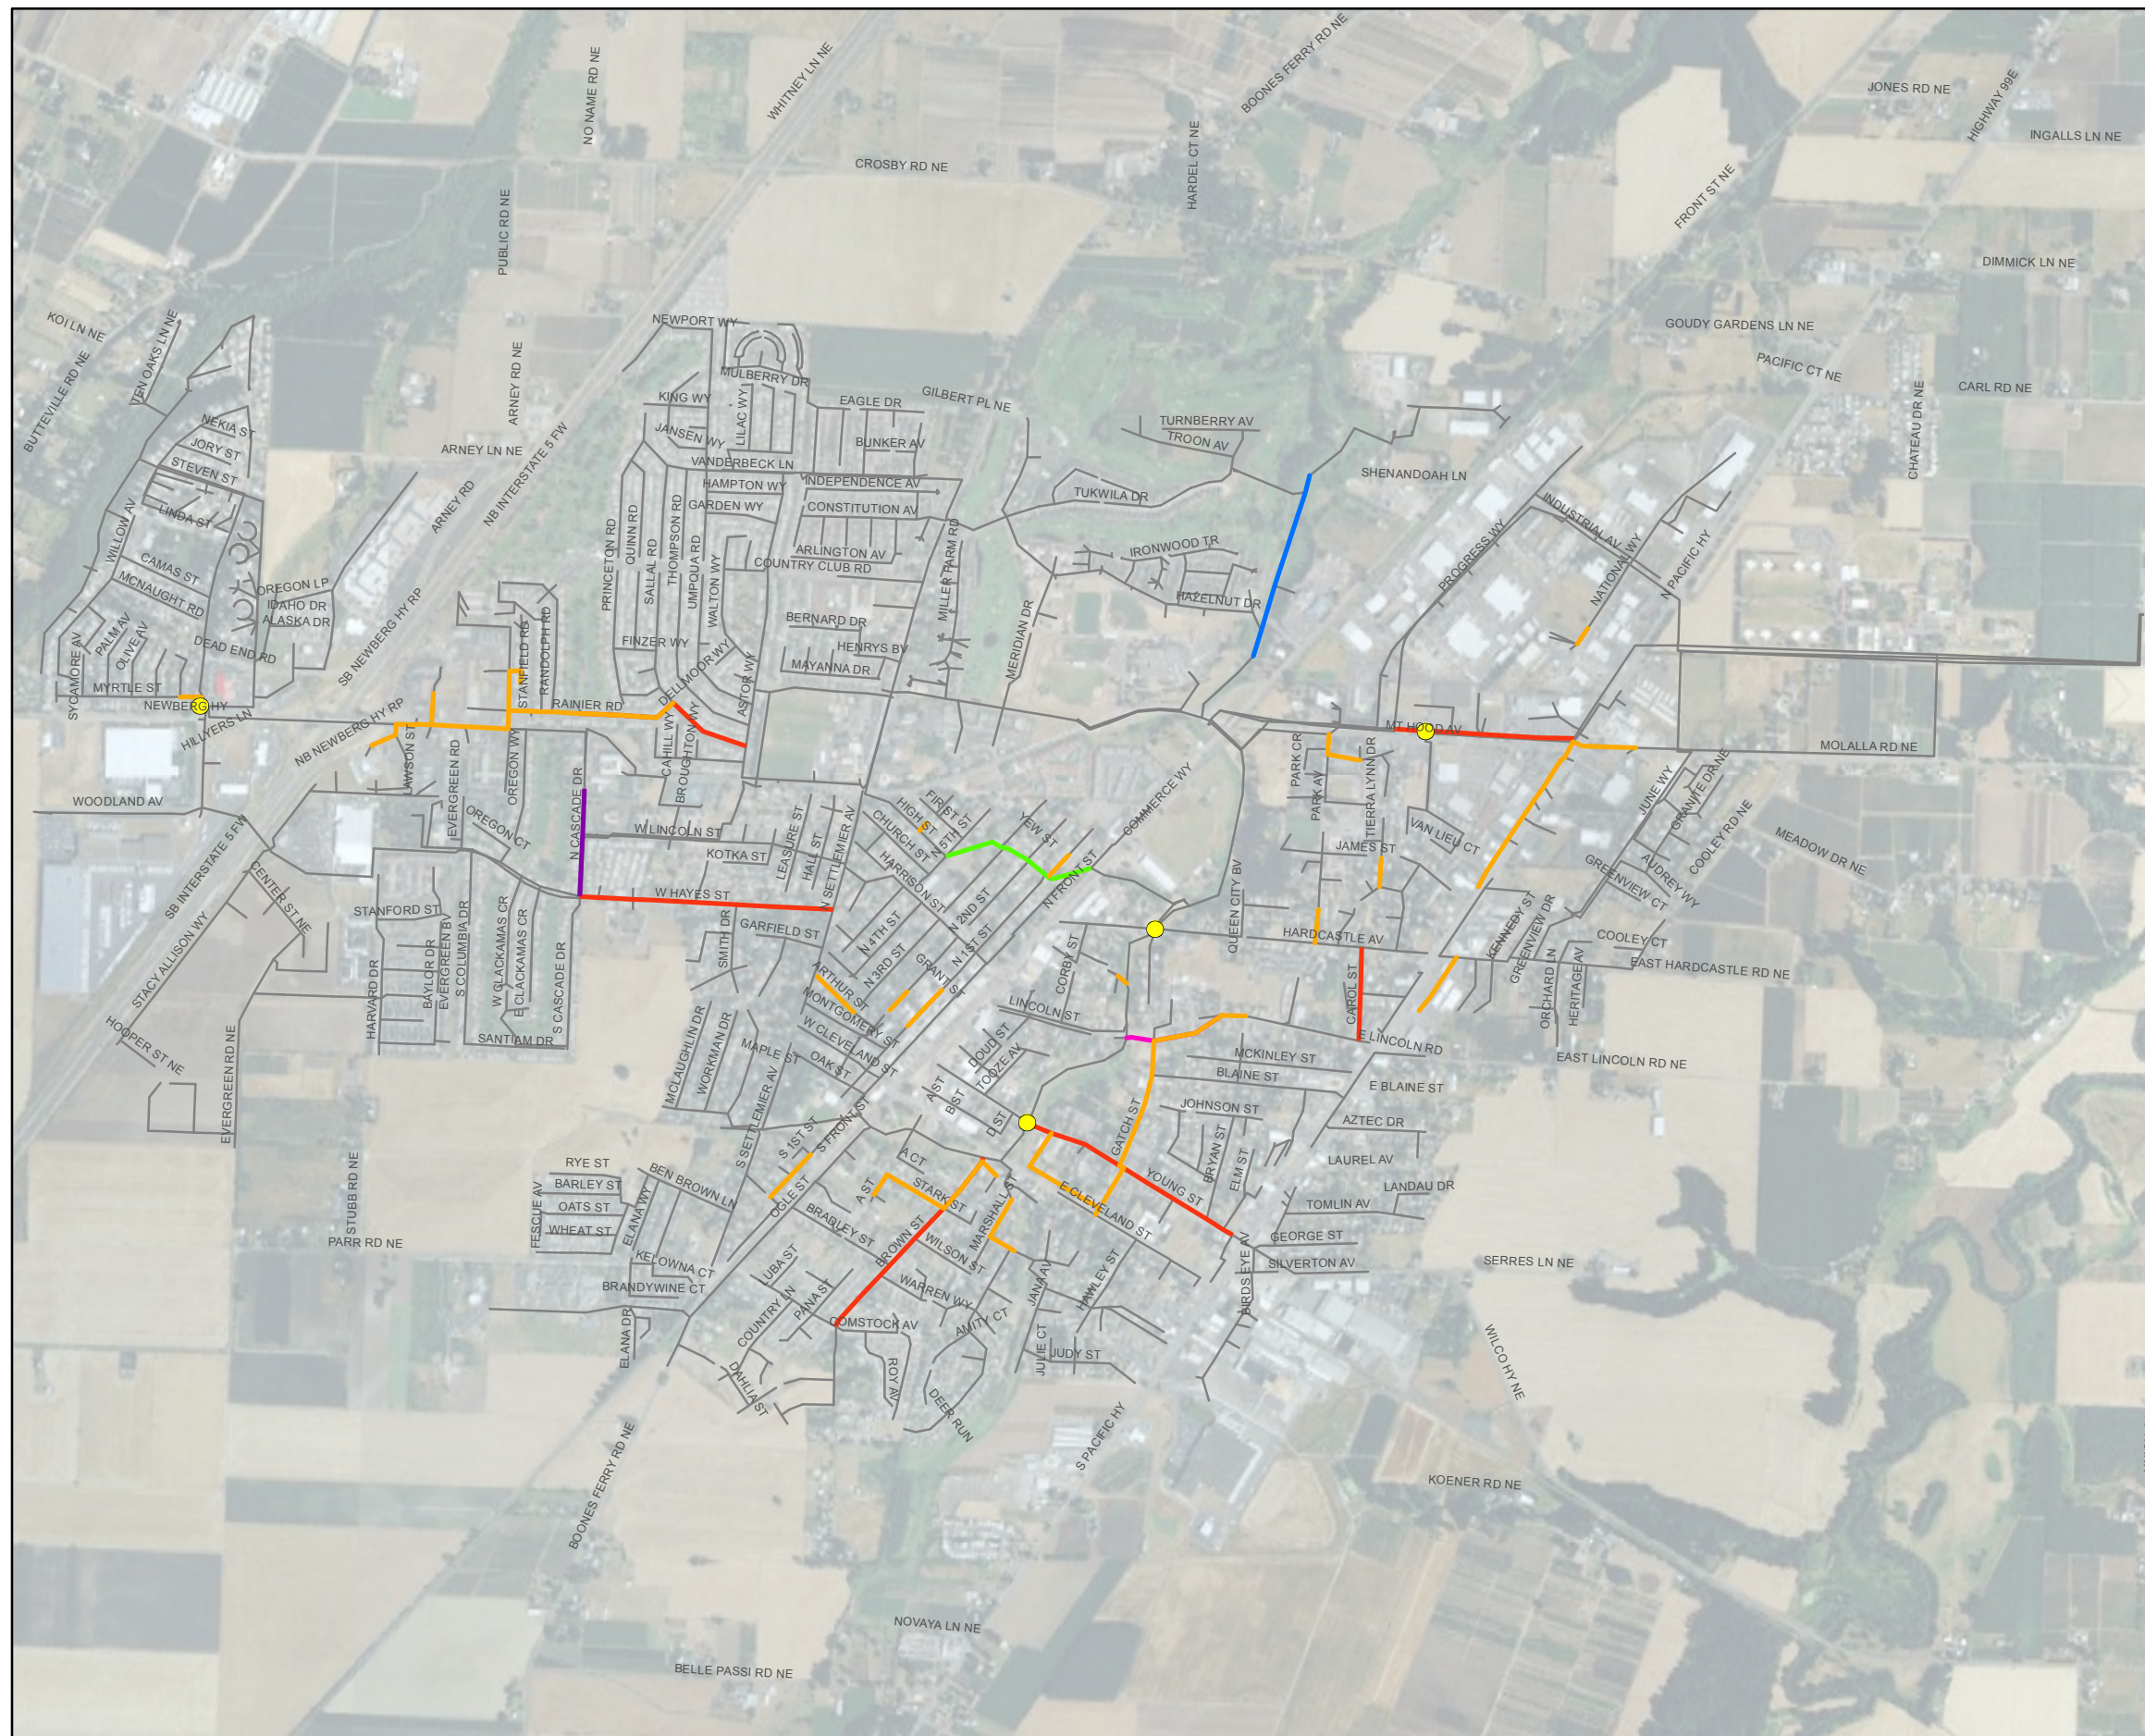
FIGURE B-7
Operation and Maintenance
Areas of Interest
 Woodburn

- LEGEND**
- Design Point
 - Collection System Pipe
- Issue**
- Capacity
 - Capacity and Grade
 - Grade
 - Grade and Easement
 - Deteriorating
 - Frequent Maintenance
